**U.S.-Canada Power System Outage Task Force**

**Final Report on the  
August 14, 2003 Blackout  
in the  
United States and Canada:**

**Causes and  
Recommendations**

**April 2004**

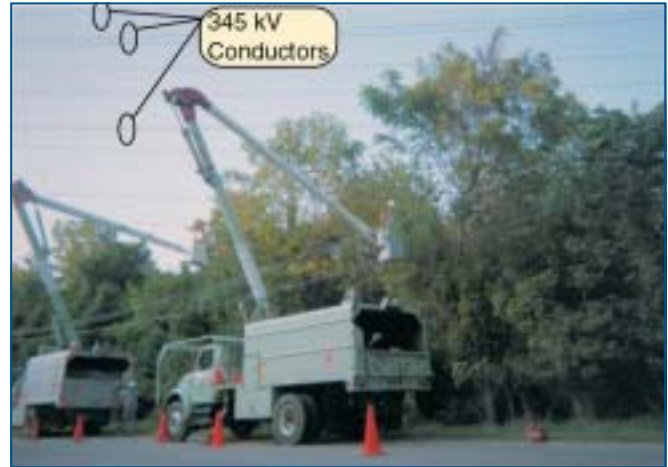
This August 14 photo shows the tree that caused the loss of the Hanna-Juniper line (tallest tree in photo). Other 345-kV conductors and shield wires can be seen in the background. Photo by Nelson Tree.
