Arizona-Southern California Outages on September 8, 2011

Causes and Recommendations

Prepared by the Staffs of the
Federal Energy Regulatory Commission
and the
North American Electric Reliability Corporation

April 2012

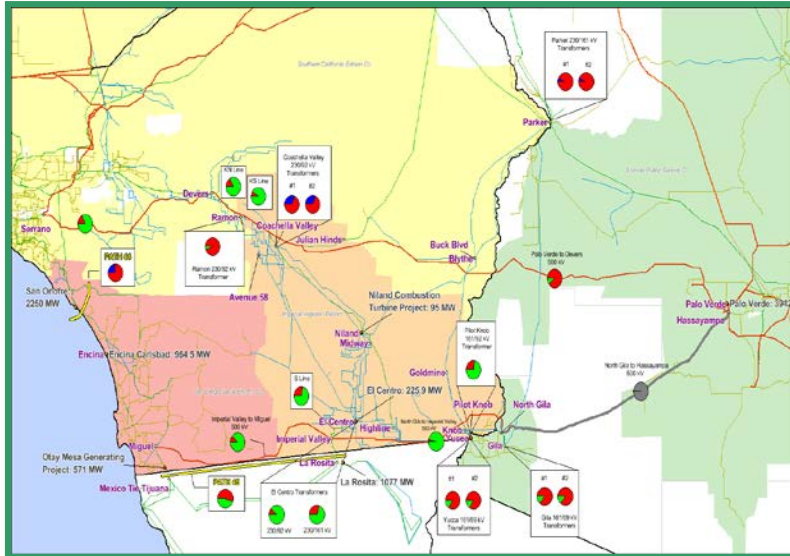
15:27:39 – The Hassayampa- North Gila 500 kV line tripped.

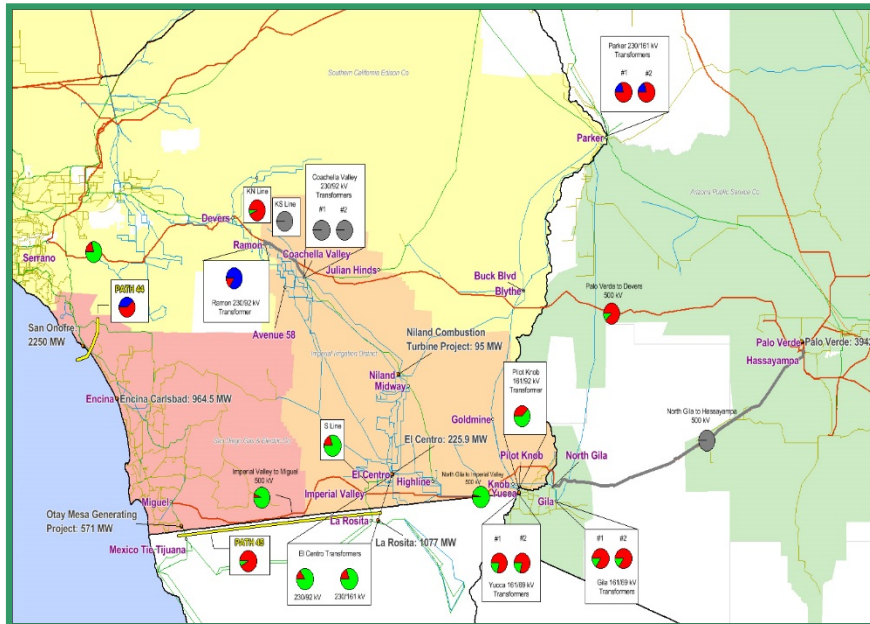
15:28:17 – Two Coachella Valley 230/92 kV transformers and the Coachella Valley Ramon 230 kV “KS” line tripped. (030)

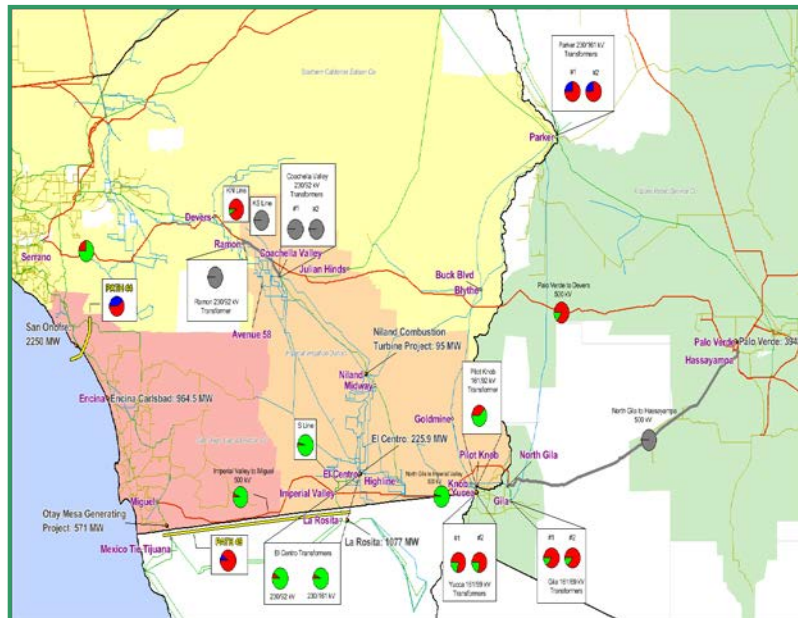
Time: 15:32:10 – The Ramon 230/92 kV transformer tripped and IID shed 444 MW of load. (110)

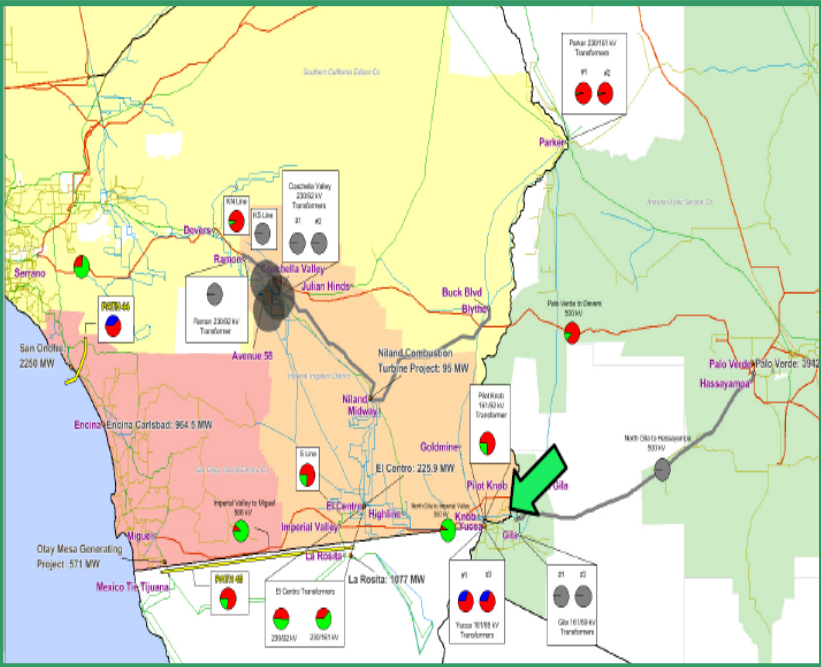
Time: 15:35:31 – Yuma Cogen (YCA) tripped. (180)

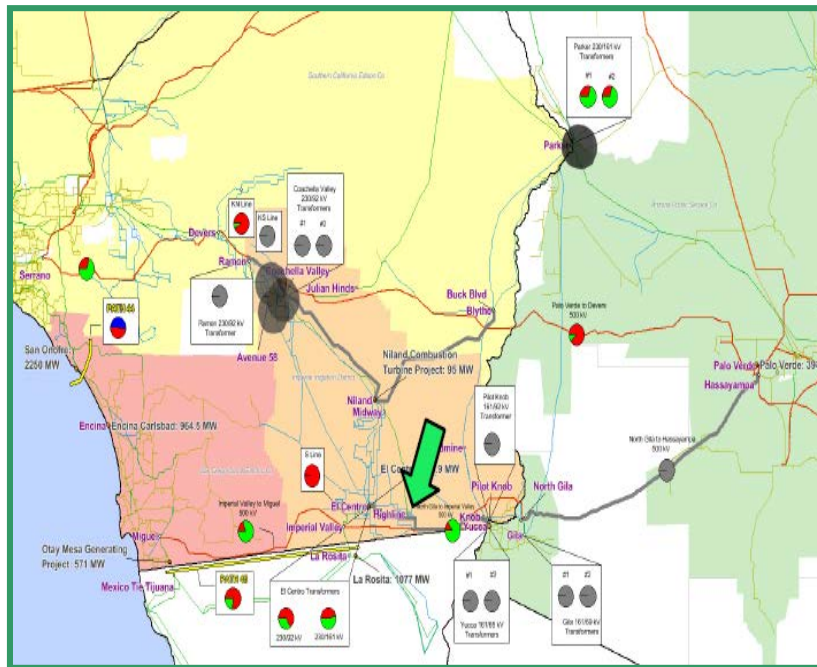
Time: 15:37:55 – The El Centro-Pilot Knob 161 kV line tripped. (230)

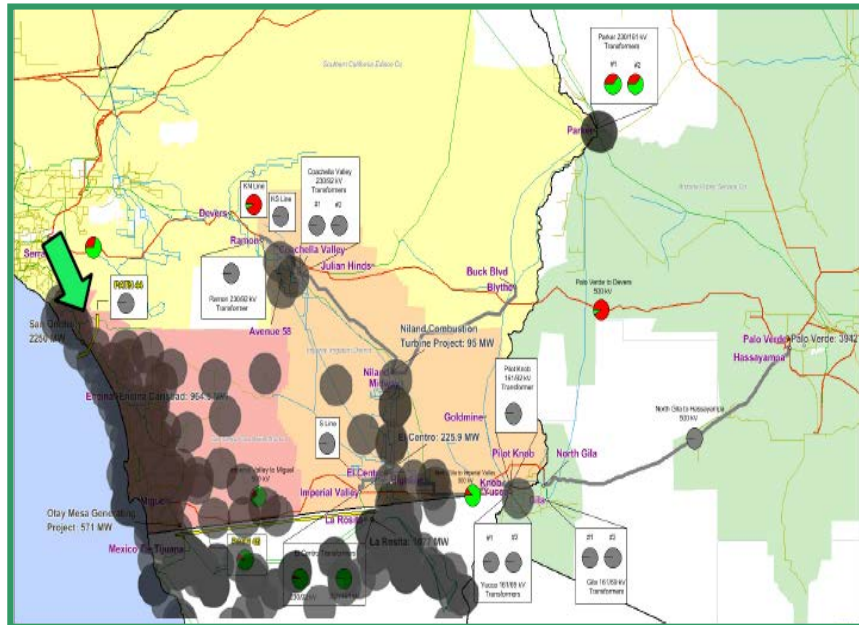
Time: 15:38:30 – The South of SONGS Separation Scheme operates and both SONGS units tripped. (300)

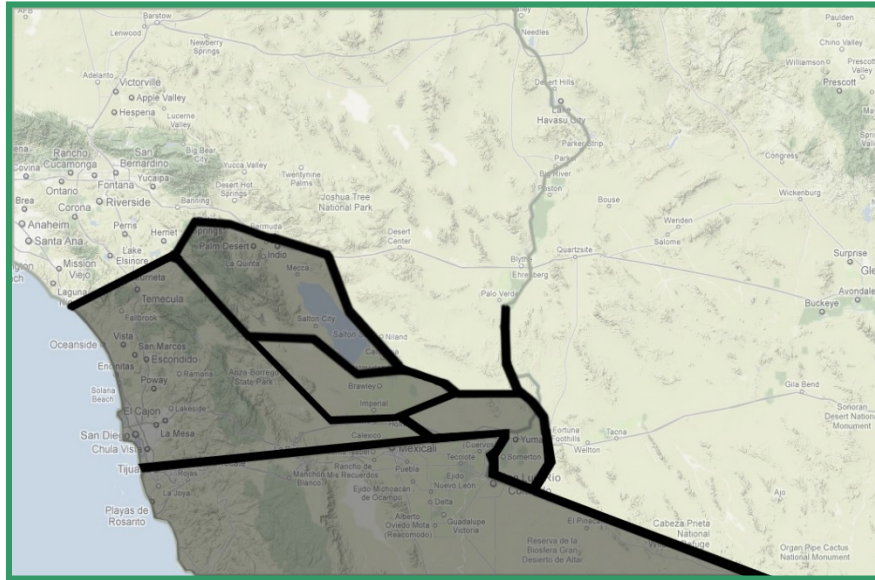
By 15:38:38, the SDG&E, CFE and Yuma islands had all collapsed, leaving approximately 2.7 million customers without power.

SDG&E, CFE, and Yuma Blackout (by 15.38.30)

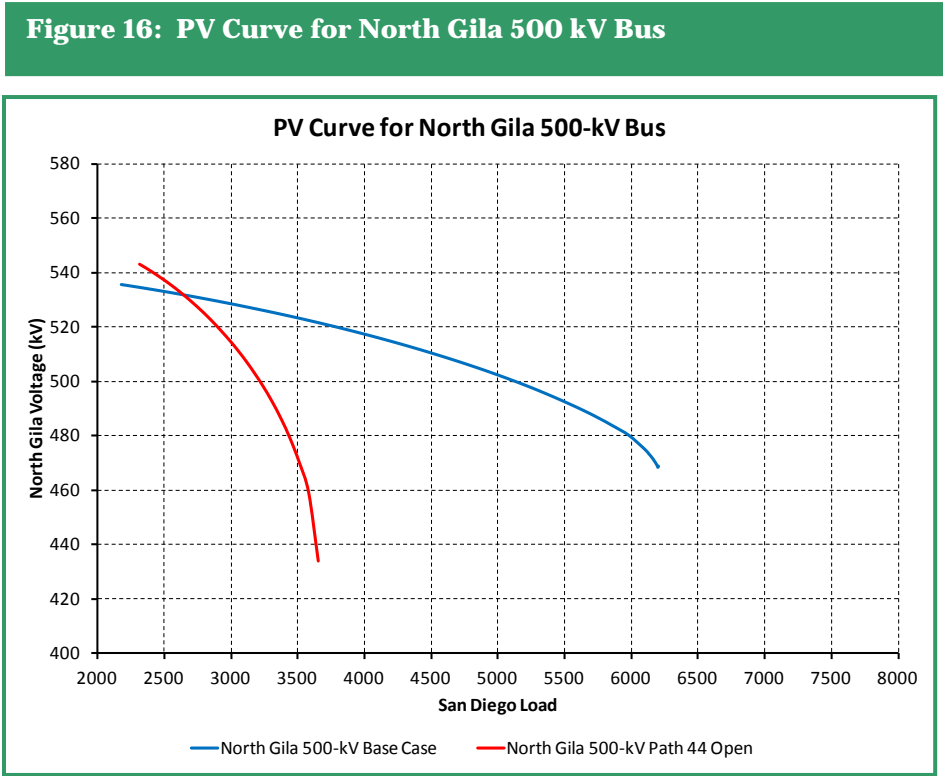
The inquiry conducted a simulation to evaluate what would happen if the SONGS separation scheme inadvertently operated during normal system operations (e.g., in the absence of any outages, overloads, or SOL violations). Based on this simulation, the inquiry determined that under certain high load conditions, the operation of the scheme could result in voltage collapse and a blackout in SDG&E’s and CFE’s territories. The inquiry conducted a voltage stability study using a Power-Voltage (P-V) curve to estimate the amount of SDG&E load that could reliably be supplied after an inadvertent operation of the SONGS separation scheme. The P-V curve below in **Figure 16** demonstrates that such operation would lead to a voltage collapse and a blackout in the SDG&E and CFE territories under certain high load conditions.

Specifically, the system is most likely to collapse when the SDG&E load exceeds 3,500 MW. In 2010, SDG&E's load exceeded this amount for 851 hours,⁹⁷ meaning that the system was exposed to a potential blackout for approximately 10% of the year. This shows the potential risk to BPS reliability during normal system operations as a result of the inadvertent operation of the SONGS separation scheme. Accordingly, given the lack of studies done on the scheme, the inquiry recommends that the inadvertent operation of the SONGS separation scheme be reviewed promptly to ensure it does not pose an unacceptable risk to BPS reliability. Until this verification can be completed, CAISO and SCE should consider all actions needed to minimize this risk, up to and including temporarily removing the scheme from service.

Moreover, if SCE and CAISO were to decide to temporarily remove the scheme from the service, the inquiry does not believe that BPS reliability would be jeopardized. Indeed, inquiry simulations conducted for the day of the event show that if the scheme had not operated, the system, with the exception of collapses in the IID and Yuma areas, would have stabilized with minor overloads in the area around SONGS, acceptable voltages in the SDG&E area, and sufficient reactive margins in the critical portion of SCE's system.
