**U.S.-Canada Power System Outage Task Force**

**Final Report on the  
August 14, 2003 Blackout  
in the  
United States and Canada:**

**Causes and  
Recommendations**

**April 2004**

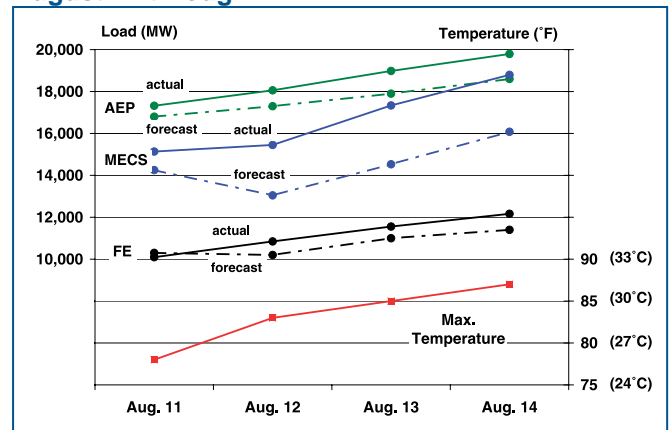
**Figure 4.2. Load Forecasts Below Actuals, August 11 through 14**

August 11 and 14. Figure 4.2 shows forecast and actual power demands for AEP, Michigan Electrical Coordinated Systems (MECS), and FE from August 11 through August 14. Variances between actual and forecast loads are not unusual, but because those forecasts are used for day-ahead planning for generation, purchases, and reactive power management, they can affect equipment availability and schedules for the following day.

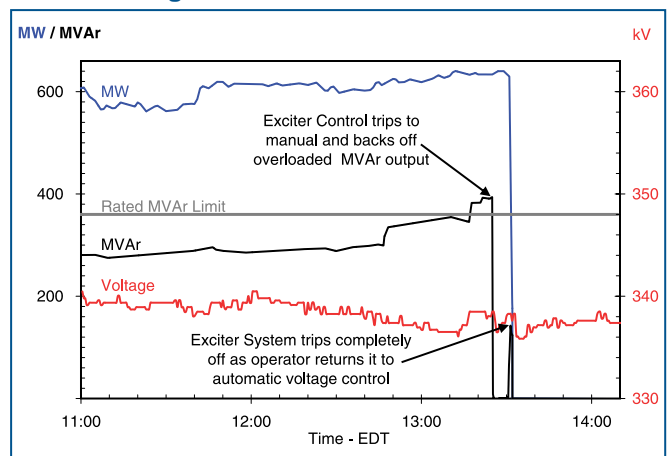
**Figure 4.3. MW and MVar Output from Eastlake Unit 5 on August 14**

- ◆ Eastlake Unit 5 is a 597 MW (net) generating unit located west of Cleveland on Lake Erie. It is a major source of reactive power support for the Cleveland area. It tripped at 13:31 EDT. The cause of the trip was that as the Eastlake 5 operator sought to increase the unit's reactive power output (Figure 4.3), the unit's protection system detected that VAR output exceeded the unit's VAR capability and tripped the unit off-line. The loss of the Eastlake 5 unit did not put the grid into an unreliable state—i.e., it was still able to withstand safely another contingency. However, the loss of the unit required FE to import additional power to make up for the loss of the unit's output (612 MW), made voltage management in northern Ohio more challenging, and gave FE operators less flexibility in operating their system (see details on pages 45-46 and 49-50).

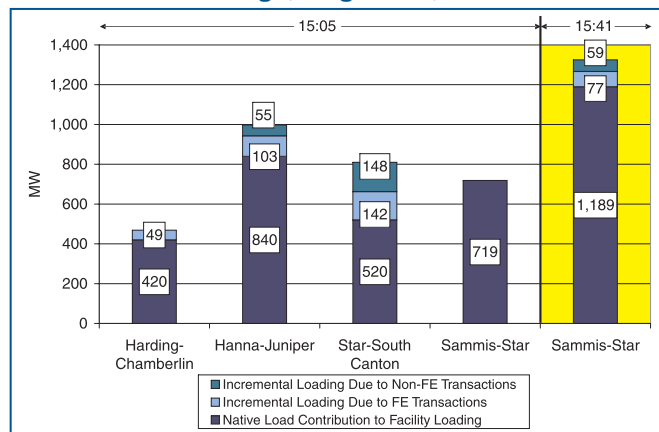
**Figure 4.6. Impacts of Transactions Flows on Critical Line Loadings, August 14, 2003**

Figure 4.6 shows how all of the transactions flowing across the Cleveland-Akron area on the afternoon of August 14 affected line loadings at key FE facilities, organized by time and types of transactions. It shows that before the first transmission line failed, the bulk of the loading on the four critical FirstEnergy circuits—Harding-Chamberlin, Hanna-Juniper, Star-South Canton and Sammis-Star—was to serve Cleveland-Akron area native load. Flows to serve native load included transfers from FE’s 1,640 MW Beaver Valley nuclear power plant and its Seneca plant, both in Pennsylvania, which have been traditionally counted by FirstEnergy not as imports but rather as in-area

generation, and as such excluded from TLR curtailments. An additional small increment of line loading served transactions for which FE was either the importer or exporter, and the remaining line loading was due to through-flows initiated and received by other entities. The Star-South Canton line experienced the greatest impact from through-flows—148 MW, or 18% of the total line loading at 15:05 EDT, was due to through-flows resulting from non-FE transactions. By 15:41 EDT, right before Star-South Canton tripped—without being overloaded—the Sammis-Star line was serving almost entirely native load, with loading from through-flows down to only 4.5%.

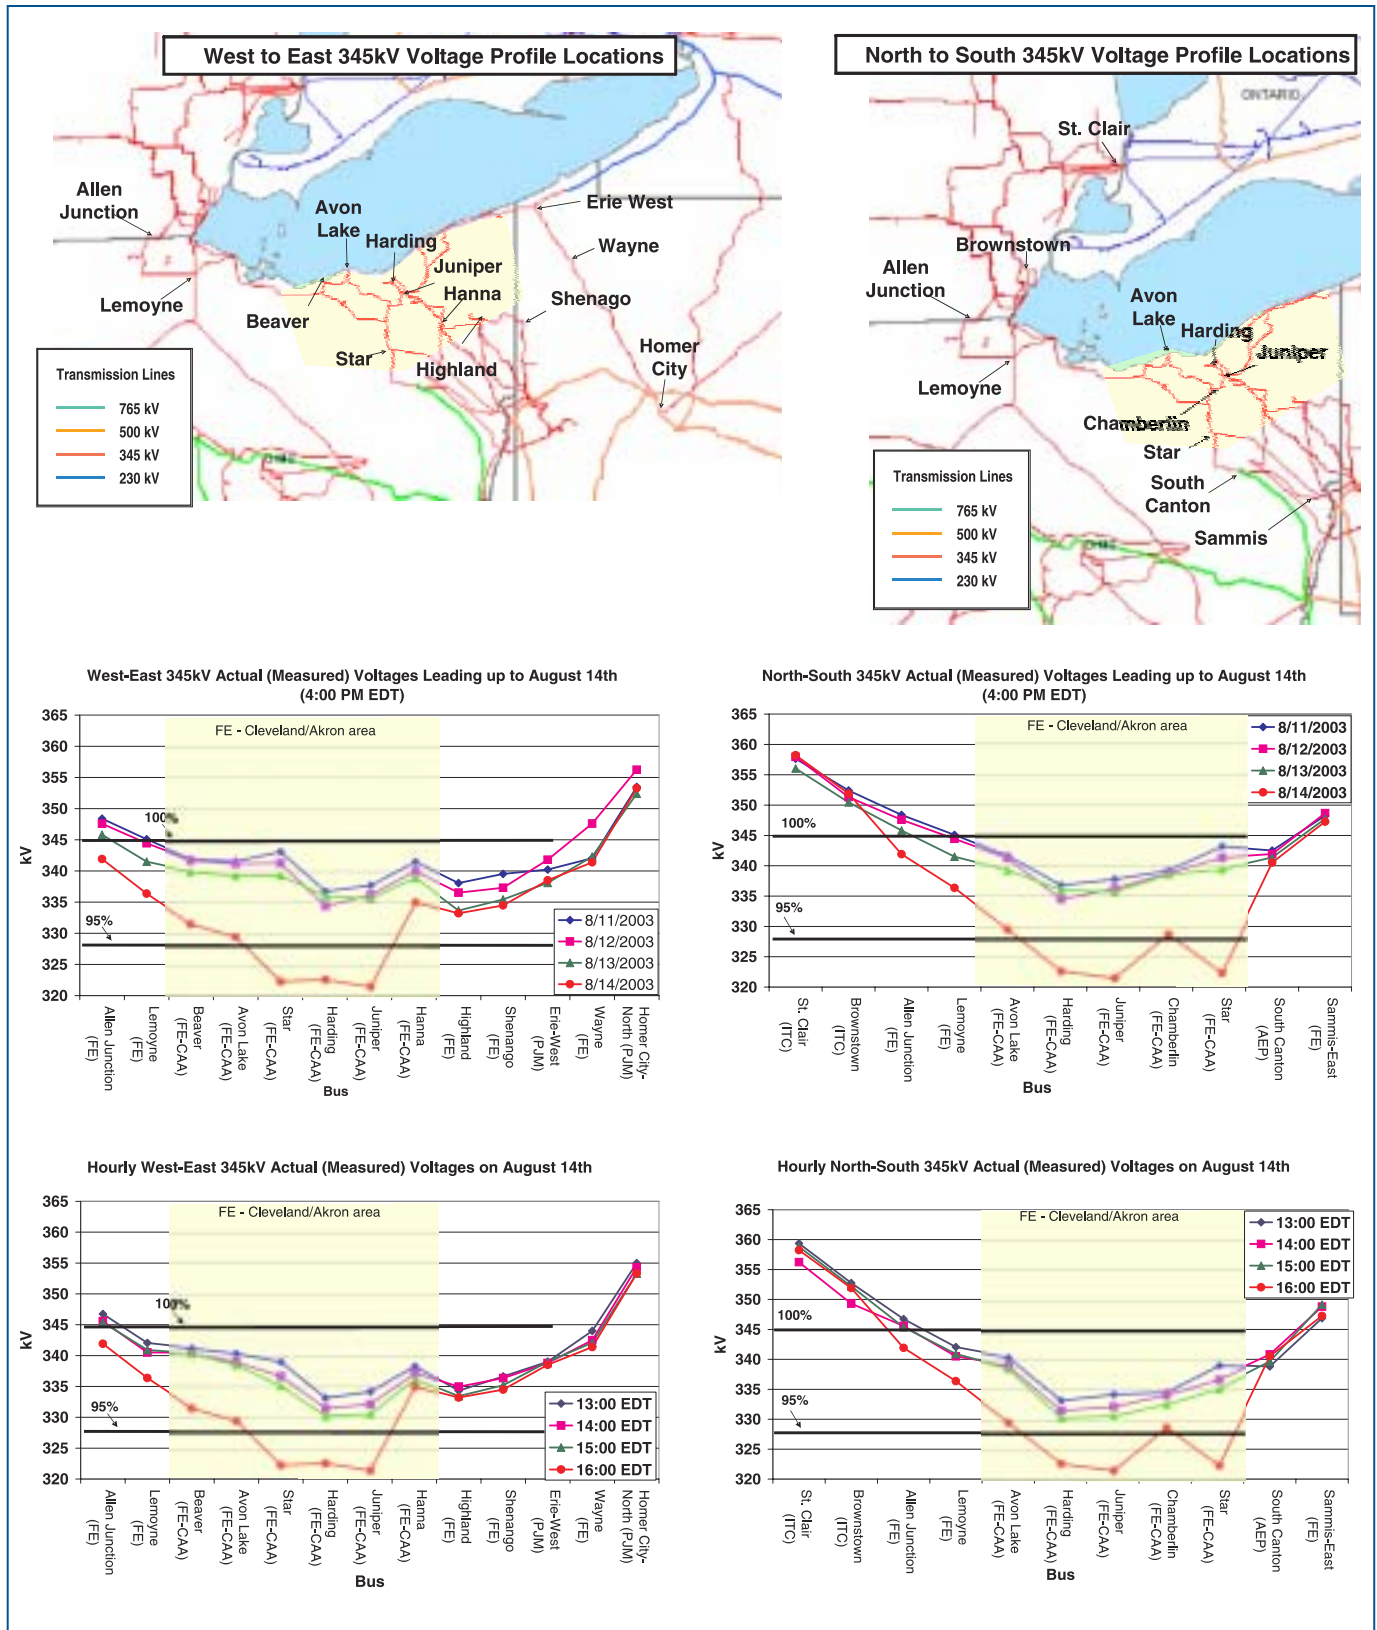
Figure 4.7. Actual Voltages Across the Ohio Area Before and On August 14, 2003

Figure 4.7 shows the profile of voltage levels at key buses from southeast Michigan across Ohio into western Pennsylvania from August 11 through 14 and for several hours on August 14. These transects show that across the area, voltage levels were consistently lower at the 345-kV buses in the Cleveland-Akron area (from Beaver to Hanna on the west to east plot and from Avon Lake to Star on the north to south plot) for the three days and the 13:00 to 15:00 EDT period preceding the blackout. Voltage was consistently and considerably higher at the outer ends of each transect, where it never dropped below 96% even on August 14. These profiles also show clearly the decline of voltage over the afternoon of August 14, with voltage at the Harding bus at 15:00 EDT just below 96% before the Harding-Chamberlin line tripped at 15:05 EDT, and dropping down to around 93% at 16:00 EDT after the loss of lines and load in the immediate area.

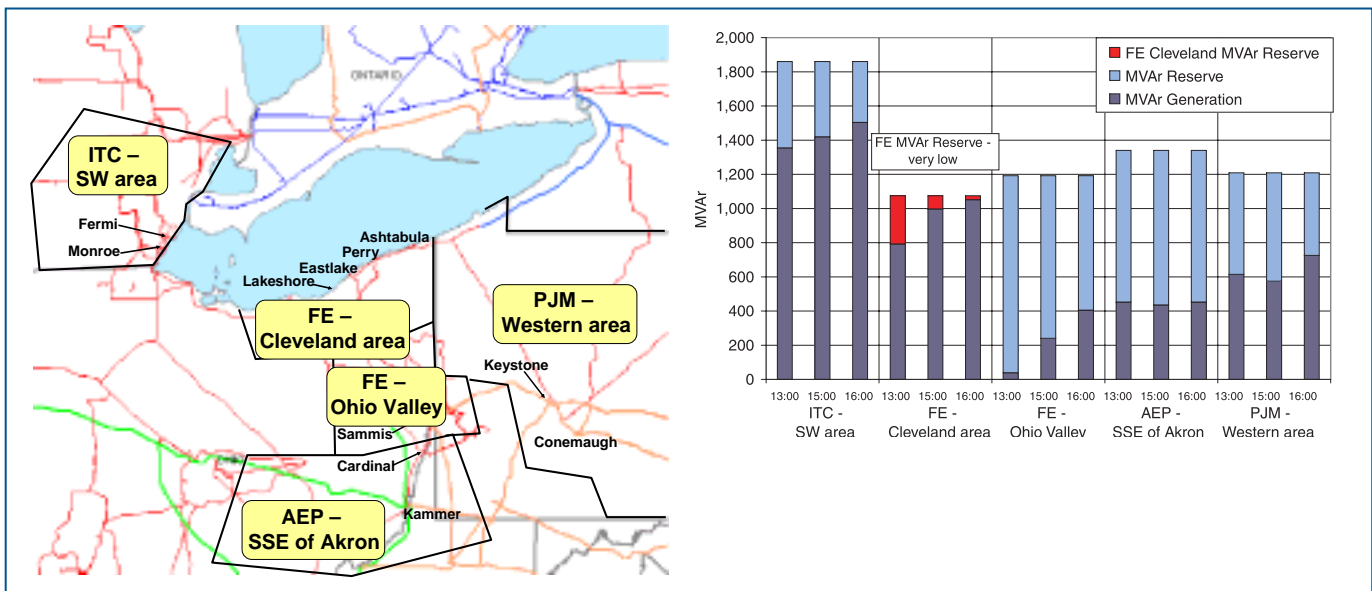
**Figure 4.8. Reactive Reserves Around Ohio on August 14, 2003, for Representative Generators in the Area**

local sources, these healthy reserves nearby could not support the Cleveland-Akron area's reactive power deficiency and growing voltage problems. Even FE's own generation in the Ohio Valley had reactive reserves that could not support the sagging voltages inside the Cleveland-Akron area.

An important consideration in reactive power planning is to ensure an appropriate balance between static and dynamic reactive power resources across the interconnected system (as specified in NERC Planning Standard 1D.S1). With so little generation left in the Cleveland-Akron area on August 14, the area's dynamic reactive reserves were depleted and the area relied heavily on static compensation to respond to changing system conditions and support voltages. But a system relying on static compensation can experience a gradual voltage degradation followed by a sudden drop in voltage stability—the P-V curve for such a system has a very steep slope close to the nose, where voltage collapses. On August 14, the lack of adequate dynamic reactive reserves, coupled with not knowing the critical voltages and maximum import capability to serve native load, left the Cleveland-Akron area in a very vulnerable state.

**Recommendation**  
23, page 160

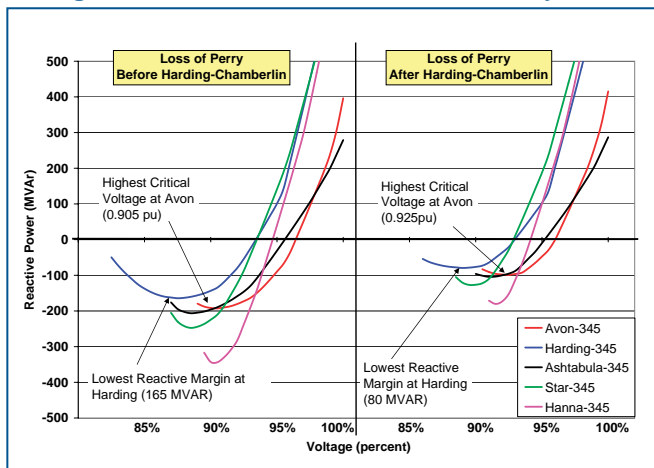
**Figure 4.9. Loss of the Perry Unit Hurts Critical Voltages and Reactive Reserves: V-Q Analyses**

To examine the impact of this worst contingency on the Cleveland-Akron area on August 14, Figure 4.9 shows the V-Q curves for key buses in the Cleveland-Akron area at 15:05 EDT, before and after the loss of the Harding-Chamberlin line. The curves on the left look at the impact of the loss of Perry before the Harding-Chamberlin trip, while the curves on the right show the impact had the nuclear plant been lost after Harding-Chamberlin went out of service. Had Perry gone down *before* the Harding-Chamberlin outage, reactive margins at key FE buses would have been minimal (with the tightest margin at the Harding bus, read along the Y-axis) and the critical voltage (the point before voltage collapse, read along the X-axis) at

the Avon bus would have risen to 90.5%—uncomfortably close to the limits which FE considered as an acceptable operating range. But had the Perry unit gone off-line *after* Harding-Chamberlin, reactive margins at all these buses would have been even tighter (with only 60 MVAR at the Harding bus), and critical voltage at Avon would have risen to 92.5%, worse than FE’s 90% minimum acceptable voltage. The system at this point would be very close to voltage instability. If the first line outage on August 14, 2003, had been at Hanna-Juniper rather than at Harding-Chamberlin, the FirstEnergy system could not have withstood the loss of the Perry plant.

**Recommendation**  
23, page 160

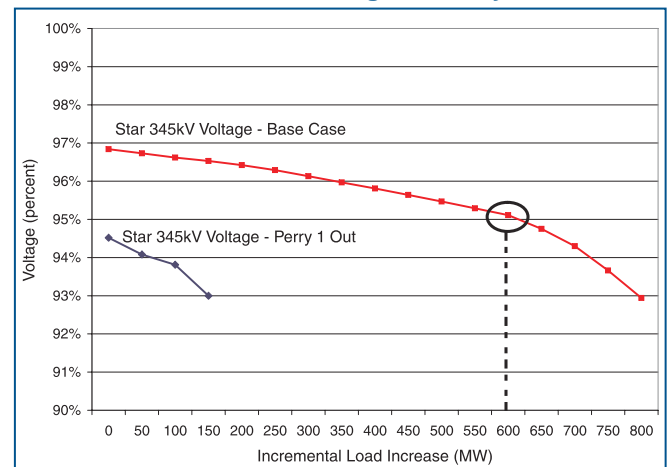
**Figure 4.10. Impact of Perry Unit Outage on Cleveland-Akron Area Voltage Stability**

load level of 13,229 MW for the control area (in August 2002). Therefore the investigation team looked at what might have happened in the Cleveland-Akron area had loads neared the historic peak—approximately 625 MW higher than the 6,715 MW peak load in the Cleveland-Akron area in 2003. Figure 4.10 uses P-V analysis to show the impact of increased load levels on voltages at the Star bus with and without the Perry unit before the loss of the Harding-Chamberlin line at 15:05 EDT. The top line shows that with the Perry plant available, local load could have increased by 625 MW and voltage at Star would have remained above 95%. But the bottom line, simulating the loss of Perry, indicates that load could only have increased by about 150 MW before voltage at Star would have become unsolvable, indicating no voltage stability margin and depending on load dynamics, possible voltage collapse.

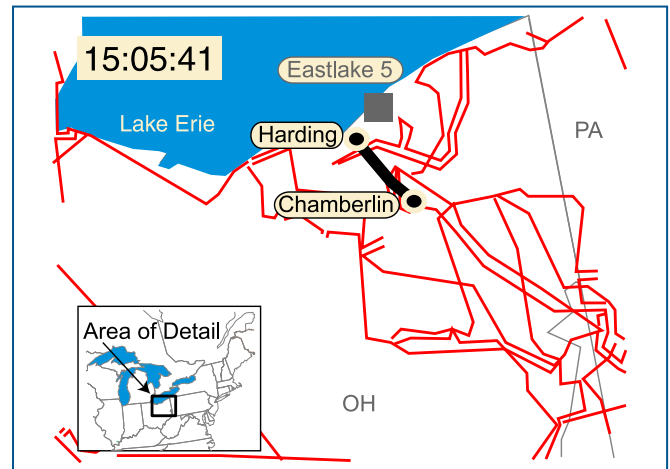
**Figure 5.8. Harding-Chamberlin 345-kV Line**

A short-circuit occurred on the Harding-Chamberlin 345-kV line due to a contact between the line conductor and a tree. This line failed with power flow at only 44% of its normal and emergency line rating. Incremental line current and temperature increases, escalated by the loss of Harding-Chamberlin, caused more sag on the Hanna-Juniper line, which contacted a tree and failed with power flow at 88% of its normal and emergency line rating. Star-South Canton

At 15:05:41 EDT, FE's Harding-Chamberlin line (Figure 5.8) tripped and locked out while loaded at 44% of its normal and emergency rating. At this low loading, the line temperature would not exceed safe levels—even if still air meant there

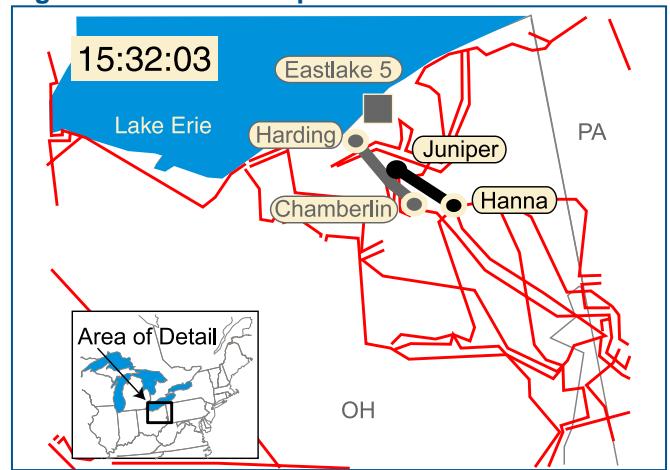
**Figure 5.9. Hanna-Juniper 345-kV Line**

At 15:32:03 EDT the Hanna-Juniper line (Figure 5.9) tripped and locked out. A tree-trimming crew was working nearby and observed the tree/line contact. The tree contact occurred on the south phase, which is lower than the center phase due to construction design. Although little evidence remained of the tree during the field team’s visit in October, the team observed a tree stump 14 inches (35.5 cm) in diameter at its ground line and talked to an individual who witnessed the contact on August 14.<sup>26</sup> Photographs clearly indicate that the tree was of excessive height (Figure 5.10). Surrounding trees were 18 inches (45.7 cm) in diameter at ground line and 60 feet (18.3 meters) in

Hanna-Juniper was loaded at 88% of its normal and emergency rating when it tripped. With this line open, over 1,200 MVA of power flow had to find a new path to reach its load in Cleveland. Loading on the remaining two 345-kV lines increased, with Star-Juniper taking the bulk of the power. This caused Star-South Canton's loading to rise above its normal but within its emergency rating and pushed more power onto the 138-kV system. Flows west into Michigan decreased slightly and voltages declined somewhat in the Cleveland area.

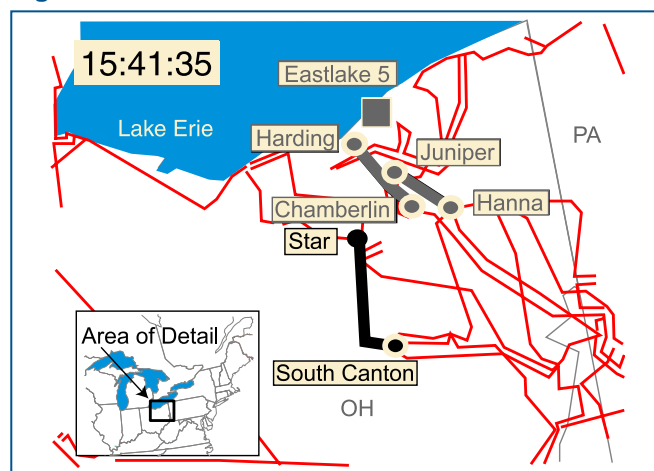
Figure 5.11. Star-South Canton 345-kV Line

The Star-South Canton line (Figure 5.11) crosses the boundary between FE and AEP—each company owns the portion of the line and manages the right-of-way within its respective territory. The Star-South Canton line tripped and reclosed three times on the afternoon of August 14, first at 14:27:15 EDT while carrying less than 55% of its emergency rating (reclosing at both ends), then at 15:38:48 and again at 15:41:33 EDT. These multiple contacts had the effect of “electric tree-trimming,” burning back the contacting limbs temporarily and allowing the line to carry more current until further sag in the still air caused the final contact and lock-out. At 15:41:35 EDT the line tripped and locked out at the Star substation, with power flow at 93% of its emergency rating. A short-circuit to ground occurred in each case.

The investigation’s field team inspected the right of way in the location indicated by the relay digital fault recorders, in the FE portion of the line. They found debris from trees and vegetation that had been felled. At this location the conductor height was 44 feet 9 inches (13.6 meters). The identifiable tree remains measured 30 feet (9.1 meters) in height, although the team could not verify the location of the stump, nor find all sections of the tree. A nearby cluster of trees showed significant fault damage, including charred limbs and de-barking from fault current. Further, topsoil in

the area of the tree trunk was disturbed, discolored and broken up, a common indication of a higher magnitude fault or multiple faults. Analysis of another stump showed that a fourteen year-old tree had recently been removed from the middle of the right-of-way.<sup>28</sup>

**Recommendations**  
16, page 154; 27, page 162

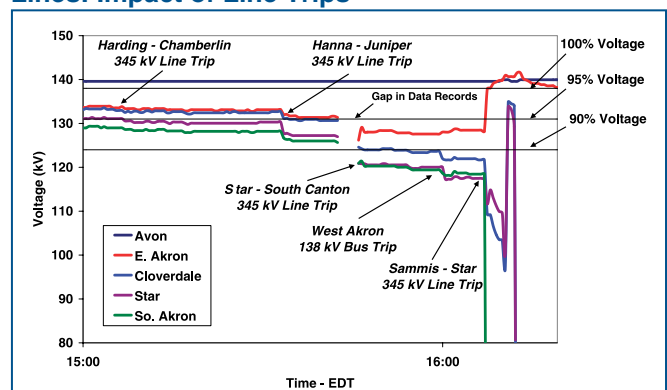
**Figure 5.14. Voltages on FirstEnergy’s 138-kV Lines: Impact of Line Trips**

Figure 5.14 shows how actual voltages declined at key 138-kV buses as the 345- and 138-kV lines were lost. As these lines failed, the voltage drops caused a number of large industrial customers with voltage-sensitive equipment to go off-line automatically to protect their operations. As the 138-kV lines opened, they blacked out customers in Akron and the areas west and south of the city, ultimately dropping about 600 MW of load.

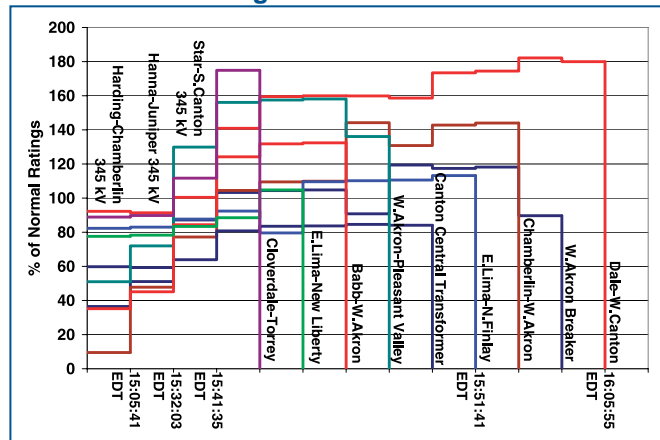
**Figure 5.15. Simulated Effect of Prior Outages on 138-kV Line Loadings**

found that 1,500 MW of load would have had to be

dropped within the Cleveland-Akron area to restore voltage at the Star bus from 90.8% (at 120% of normal and emergency ampere rating) up to 95.9% (at 101% of normal and emergency ampere rating).<sup>44</sup> The P-V and V-Q analysis reviewed in Chapter 4 indicated that 95% is the minimum operating voltage appropriate for 345-kV buses in the Cleveland-Akron area. The investigation team concluded that since the Sammis-Star 345 kV outage was the critical event leading to widespread cascading in Ohio and beyond, if manual or automatic load-shedding of 1,500 MW had occurred within the Cleveland-Akron area before that outage, the blackout could have been averted.

Figure 5.15, derived from investigation team modeling, shows how the power flows shifted across FE's 345- and key 138-kV northeast Ohio lines as the line failures progressed. All lines were loaded within normal limits after the Harding-Chamberlin lock-out, but after the Hanna-Juniper trip at 15:32 EDT, the Star-South Canton 345-kV line and three 138-kV lines jumped above normal loadings. After Star-South Canton locked out at 15:41 EDT within its emergency rating, five 138-kV and the Sammis-Star 345-kV lines were overloaded. From that point, as the graph shows, each subsequent line loss increased loadings on other lines, some loading to well over 150% of normal ratings before they failed. The Sammis-Star 345-kV line stayed in service until it tripped at 16:05:57 EDT.

**Recommendations**  
8, page 147; 21, page 158; 23, page 160

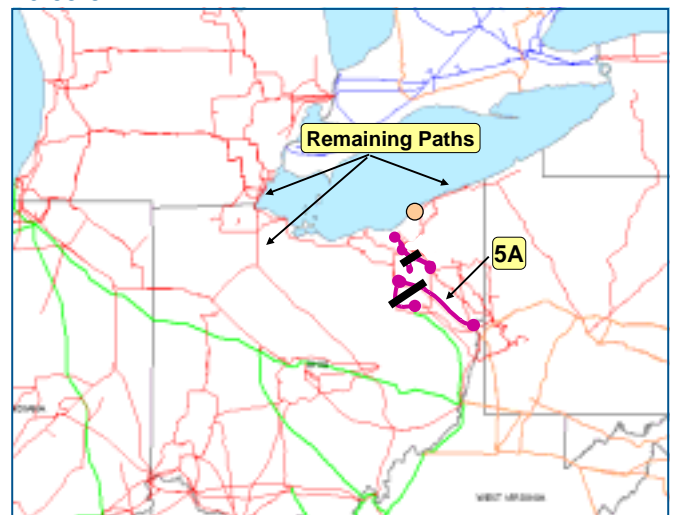
**Figure 6.3. Sammis-Star 345-kV Line Trip, 16:05:57 EDT**

After the loss of FE's Sammis-Star 345-kV line and the underlying 138-kV system, there were no large capacity transmission lines left from the south to support the significant amount of load in northern Ohio (Figure 6.3). This overloaded the

The Sammis-Star 345-kV line trip completely severed the 345-kV path into northern Ohio from southeast Ohio, triggering a new, fast-paced sequence of 345-kV transmission line trips in which each line trip placed a greater flow burden on those lines remaining in service. These line outages left only three paths for power to flow into western Ohio: (1) from northwest Pennsylvania to northern Ohio around the south shore of Lake Erie, (2) from southwest Ohio toward northeast Ohio, and (3) from eastern Michigan and Ontario. The line interruptions substantially weakened northeast Ohio as a source of power to eastern Michigan, making the Detroit area more reliant on 345-kV lines west and northwest of Detroit, and from northwestern Ohio to eastern Michigan. The impact of this trip was felt across the grid—it caused a 100 MW increase in flow from PJM into New York and through to Ontario.<sup>1</sup> Frequency in the Eastern Interconnection increased momentarily by 0.02 Hz.

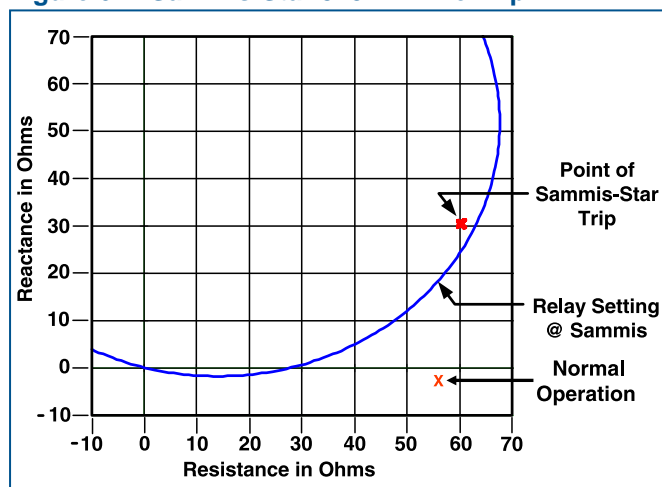
**Figure 6.4. Sammis-Star 345-kV Line Trip**

Sammis-Star did not trip due to a short circuit to ground (as did the prior 345-kV lines that tripped). Sammis-Star tripped due to protective zone 3 relay action that measured low apparent impedance (depressed voltage divided by abnormally high line current) (Figure 6.4). There was no fault and no major power swing at the time of the trip—rather, high flows above the line's emergency rating together with depressed voltages caused the overload to appear to the protective relays as a remote fault on the system. In effect, the relay could no longer differentiate between a remote three-phase fault and an exceptionally high line-load condition. Moreover, the reactive flows (VAr) on the line were almost ten times higher than they had been earlier in the day because of the current overload. The relay operated as it was designed to do.

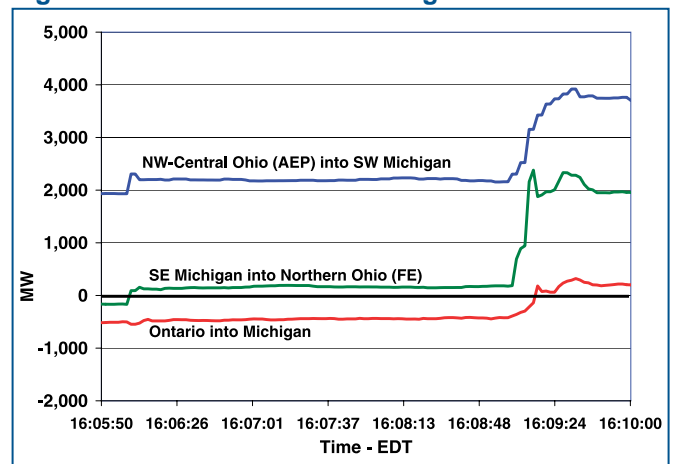
**Figure 6.5. Line Flows Into Michigan**

overloading and tripping within Ohio, this was happening slowly enough under relatively stable conditions that the system could readjust—after each line loss, power flows would redistribute across the remaining lines. This is illustrated in Figure 6.5, which shows the MW flows on the Michigan Electrical Coordinated Systems (MECS) interfaces with AEP (Ohio), FirstEnergy (Ohio) and Ontario. The graph shows a shift from 150 MW imports to 200 MW exports from the MECS system into FirstEnergy at 16:05:57 EDT after the loss of Sammis-Star, after which this held steady until 16:08:59, when the loss of East Lima-Fostoria Central cut the main energy path from the south and west into Cleveland and Toledo. Loss of this path was significant, causing flow from MECS into FE to jump from 200 MW up to 2,300 MW, where it bounced somewhat before stabilizing, roughly, until the path across Michigan was cut at 16:10:38 EDT.

Note: These curves use data collected from the MECS Energy Management System, which records flow quantities every 2 seconds. As a result, the fast power swings that occurred between 16:10:36 to 16:13 were not captured by the recorders and are not reflected in these curves.

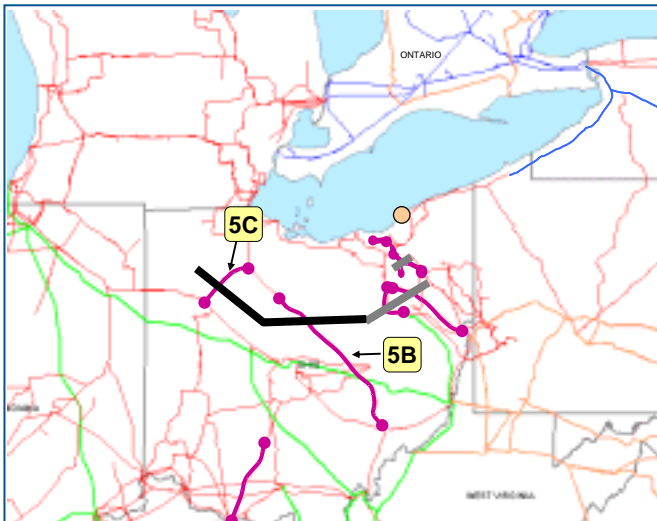
**Figure 6.6. Ohio 345-kV Lines Trip, 16:08:59 to 16:09:07 EDT**

345-kV transmission lines removed the transmission paths from southern and western Ohio into northern Ohio and eastern Michigan. Northern Ohio was connected to eastern Michigan by only three 345-kV transmission lines near the southwestern bend of Lake Erie. Thus, the combined northern Ohio and eastern Michigan load centers were left connected to the rest of the grid only by: (1) transmission lines eastward from northeast Ohio to northwest Pennsylvania along the southern shore of Lake Erie, and (2) westward by lines west and northwest of Detroit, Michigan and from Michigan into Ontario (Figure 6.6).

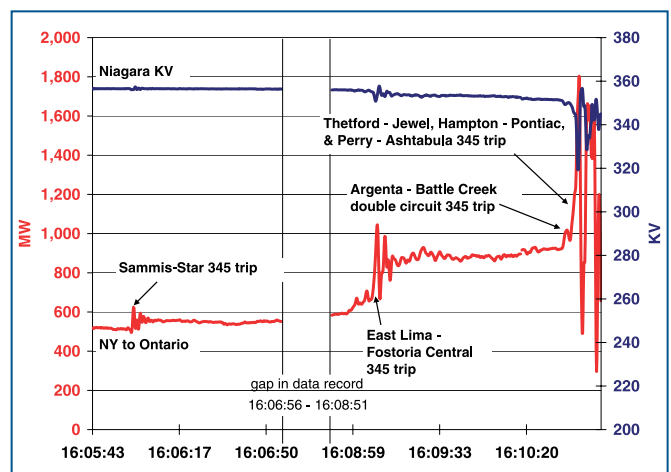
**Figure 6.7. New York-Ontario Line Flows at Niagara**

shows the impact of the East Lima-Fostoria Central and the New York to Ontario power swing, which continued to oscillate for over 10 seconds. Looking at the MW flow line, it is clear that when Sammis-Star tripped, the system experienced oscillations that quickly damped out and rebalanced. But East Lima-Fostoria triggered significantly greater oscillations that worsened in magnitude for several cycles, and returned to stability but continued to flutter until the Argenta-Battle Creek trip 90 seconds later. Voltages also began declining at this time.

Figure 6.7 also shows the magnitude of subsequent flows and voltages at the New York-Ontario Niagara border, triggered by the trips of the Argenta-Battle Creek, Argenta-Tompkins, Hampton-Pontiac and Thetford-Jewell 345-kV lines in Michigan, and the Erie West-Ashtabula-Perry

As the cascade progressed beyond Ohio, it spread due not to insufficient reactive power and a voltage collapse, but because of dynamic power swings and the resulting system instability. Figure 6.7 shows voltage levels recorded at the Niagara area. It shows clearly that voltage levels remained stable until 16:10:30 EDT, despite significant power fluctuations. In the cascade that followed, the voltage instability was a companion to, not a driver of, the angle instability that tripped generators and lines.

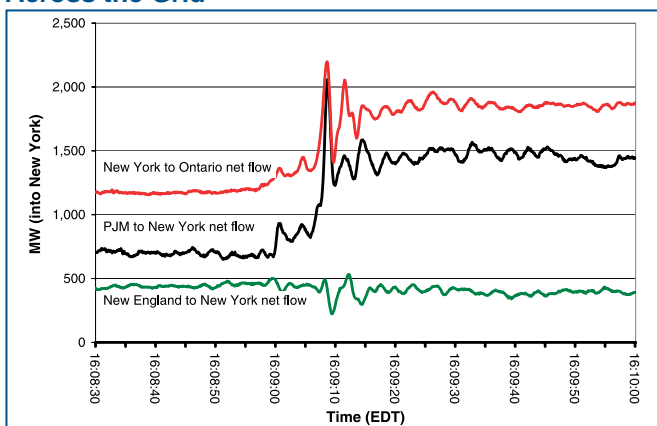
**Figure 6.8. First Power Swing Has Varying Impacts Across the Grid**

Figure 6.8, of metered power flows along the New York interfaces, documents how the flows heading north and west toward Detroit and Cleveland varied at different points on the grid. Beginning at 16:09:05 EDT, power flows jumped simultaneously across all three interfaces—but when the first power surge peaked at 16:09:09, the change in flow was highest on the PJM interface and lowest on the New England interface. Power flows increased significantly on the PJM-NY and NY-Ontario interfaces because of the redistribution of flow around Lake Erie. The New England and Maritime systems maintained the same generation to load balance and did not carry the redistributed flows because they were not in the direct path of the flows, so that interface with New York showed little response.

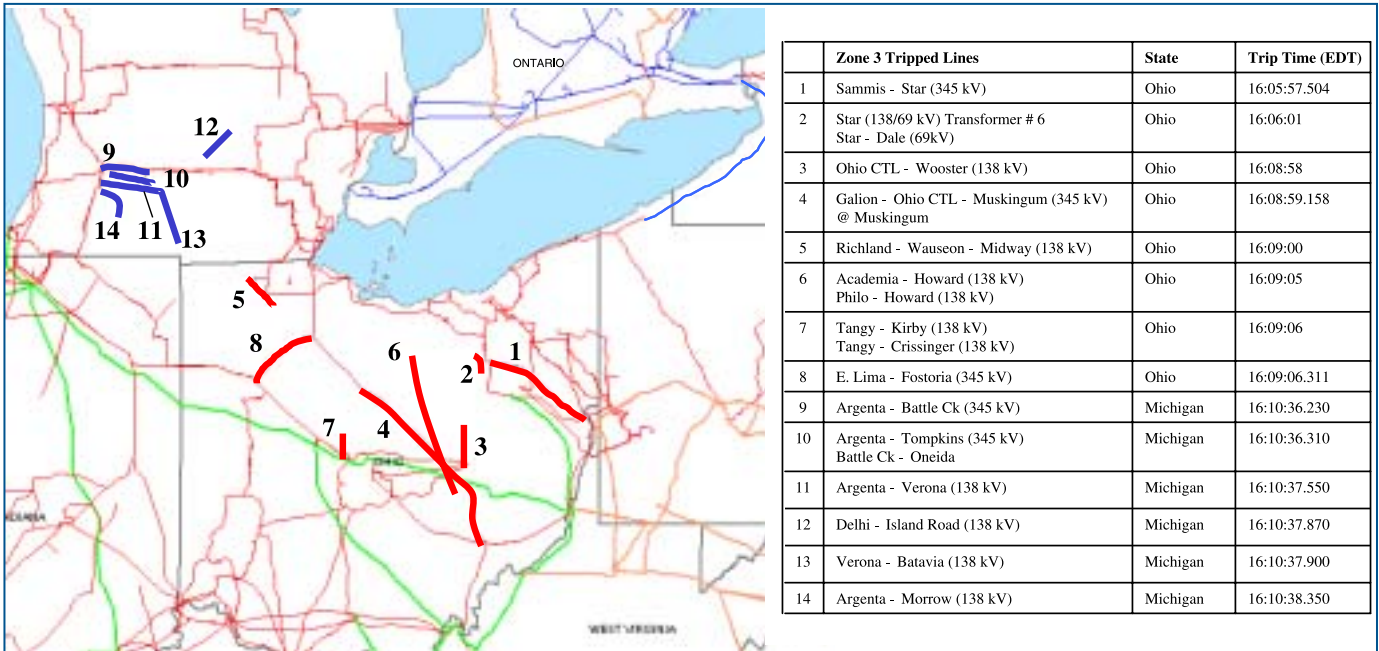
Figure 6.9. Map of Zone 3 (and Zone 2s Operating Like Zone 3s) Relay Operations on August 14, 2003

The Sammis-Star line tripped at 16:05:57 EDT on a zone 3 impedance relay although there were no faults occurring at the time, because increased real and reactive power flow caused the apparent impedance to be within the impedance circle (reach) of the relay. Between 16:06:01 and 16:10:38.6 EDT, thirteen more important 345 and 138-kV lines tripped on zone 3 operations that afternoon at the start of the cascade, including Galion-Ohio Central-Muskingum, East Lima-Fostoria Central, Argenta-Battle Creek, Argenta-Tompkins, Battle Creek-Oneida, and Perry-Ashtabula (Figure 6.9). These included several zone 2 relays in Michigan that had been set to operate like zone 3s, overreaching the line by more than 200% with no intentional time delay for remote breaker failure protection.<sup>3</sup> All of these relays operated according to their settings. However, the zone 3 relays (and zone 2 relays acting like zone 3s) acted so quickly that they impeded the natural ability of the electric system to hold together, and did not allow for any operator intervention to attempt to stop the spread of the cascade. The investigation team concluded that because these zone 2 and 3 relays tripped after each line overloaded, these relays were the common mode of failure that accelerated the geographic spread of the cascade. Given grid conditions and loads and the limited operator tools available, the speed of the zone 2 and 3 operations across Ohio and Michigan eliminated any possibility after 16:05:57 EDT that either operator action or automatic intervention could have limited or mitigated the growing cascade.

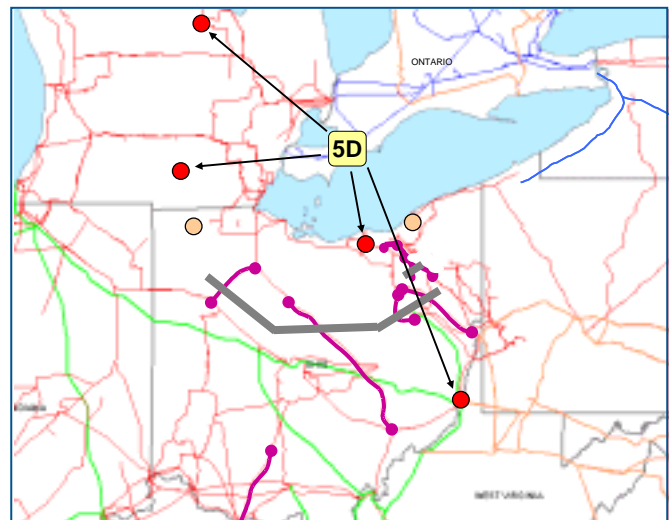
**Figure 6.10. Michigan and Ohio Power Plants Trip**

The Burger units tripped after the 138-kV lines into the Burger 138-kV substation (Ohio) tripped from the low voltages in the Cleveland area (Figure 6.10). The MCV plant is in central Michigan. Kinder Morgan is in south-central Michigan. The Kinder-Morgan units tripped due to a transformer fault and one due to over-excitation.

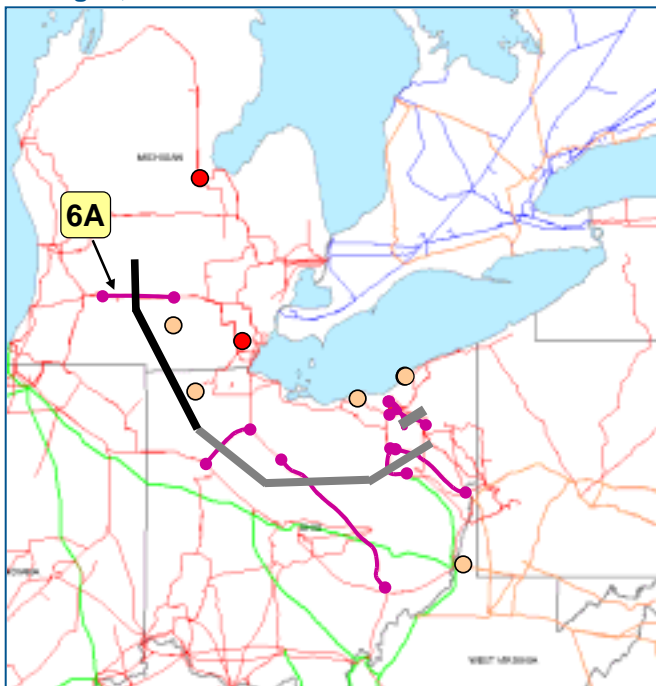
**Figure 6.11. Transmission and Generation Trips in Michigan, 16:10:36 to 16:10:37 EDT**

under-voltage on the system. Michigan lines west of Detroit then began to trip, as shown in Figure 6.11.

The Argenta-Battle Creek relay first opened the line at 16:10:36.230 EDT, reclosed it at 16:10:37, then tripped again. This line connects major generators—including the Cook and Palisades nuclear plants and the Campbell fossil plant—to the MECS system. This line is designed with auto-reclose breakers at each end of the line, which do an automatic high-speed reclose as soon as they open to restore the line to service with no interruptions. Since the majority of faults on the North American grid are temporary, automatic reclosing can enhance stability and system reliability. However, situations can occur when the power systems behind the two ends of the line could go out of phase during the high-speed reclose period (typically less than 30 cycles, or one half second, to allow the air to de-ionize after the trip to prevent arc re-ignition). To address this and protect generators from the harm that an out-of-synchronism reconnect could cause, it is worth studying whether a synchro-check relay is needed, to reclose the second breaker only when the two ends are within a certain voltage and phase angle tolerance. No such protection was installed at Argenta-Battle Creek; when the line reclosed, there was a 70° difference in phase across the circuit breaker reclosing the line. There

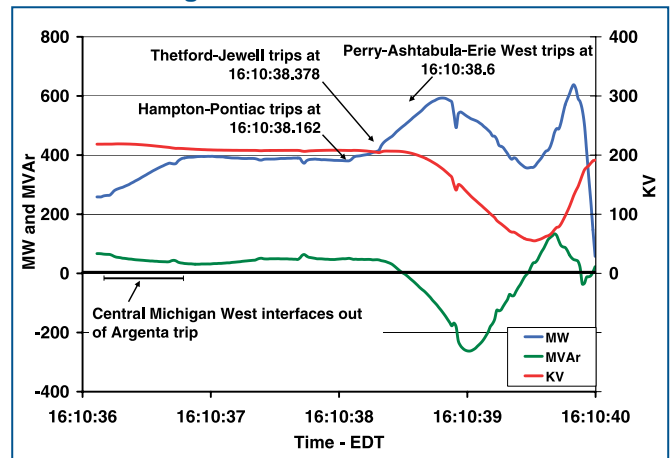
**Figure 6.12. Flows on Keith-Waterman 230-kV Ontario-Michigan Tie Line**

The Power System Disturbance Recorders at Keith and Lambton, Ontario, captured these events in the flows across the Ontario-Michigan interface, as shown in Figure 6.12 and Figure 6.16. It shows clearly that the west to east Michigan separation (the Thetford-Jewell trip) was the start and Erie West-Ashtabula-Perry was the trigger for the 3,700 MW surge from Ontario into Michigan. When Thetford-Jewell tripped, power that had been flowing into Michigan and Ohio from western Michigan, western Ohio and Indiana was cut off. The nearby Ontario recorders saw a pronounced impact as flows into Detroit readjusted to draw power from the northeast instead. To the south,

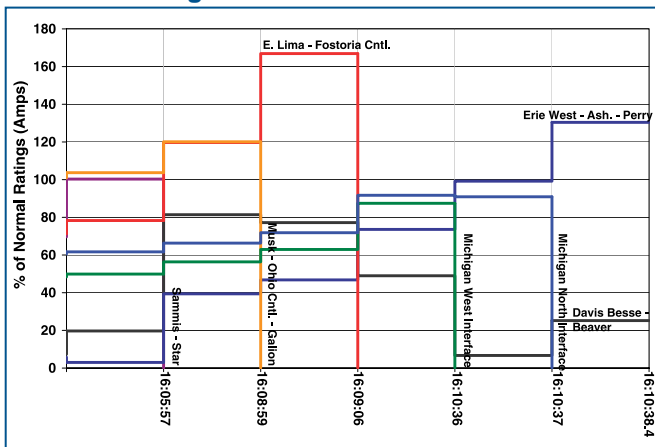
**Figure 6.13. Simulated 345-kV Line Loadings from 16:05:57 through 16:10:38.4 EDT**

Figures 6.13 and 6.14 show the results of investigation team modeling of the line loadings on the Ohio, Michigan, and other regional interfaces for the period between 16:05:57 until the Thetford-Jewell trip, to understand how power flows shifted during this period. The team simulated evolving system conditions on August 14, 2003, based on the 16:05:50 power flow case developed by the MAAC-ECAR-NPCC Operations Studies Working Group. Each horizontal line in the graph indicates a single or set of 345-kV lines and its loading as a function of normal ratings over time as first one, then another, set of circuits tripped out of service. In general, each subsequent line trip causes the remaining line loadings to rise; where a line drops (as Erie West-Ashtabula-Perry in Figure 6.13 after the Hanna-Juniper trip), that indicates that line loading lightened, most likely due to customers dropped from service. Note that Muskingum and East Lima-Fostoria Central were overloaded before they tripped, but the Michigan west and north interfaces were not overloaded before they tripped. Erie West-Ashtabula-Perry was loaded to 130% after the Hampton-Pontiac and Thetford-Jewell trips.

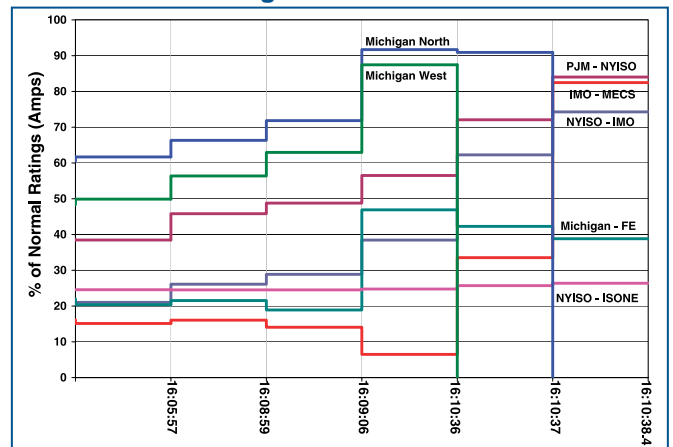
**Figure 6.14. Simulated Regional Interface Loadings from 16:05:57 through 16:10:38.4 EDT**

The Regional Interface Loadings graph (Figure 6.14) shows that loadings at the interfaces between PJM-NY, NY-Ontario and NY-New England were well within normal ratings before the east-west Michigan separation.

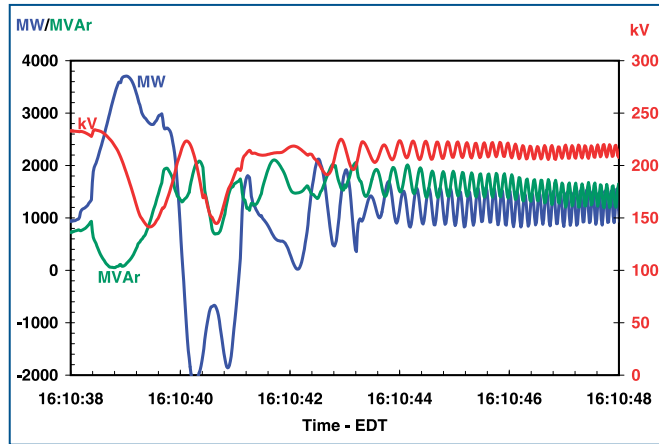
**Figure 6.16. Active and Reactive Power and Voltage from Ontario into Detroit**

This was a power surge of large magnitude, so frequency was not the same across the Eastern Interconnection. As Figure 6.16 shows, the power swing resulted in a rapid rate of voltage decay. Flows into Detroit exceeded 3,700 MW and 1,500 MVAR—the power surge was draining real power out of the northeast, causing voltages in Ontario and New York to drop. At the same time, local voltages in the Detroit area were plummeting because Detroit had already lost 500 MW of local generation. Detroit would soon lose synchronism

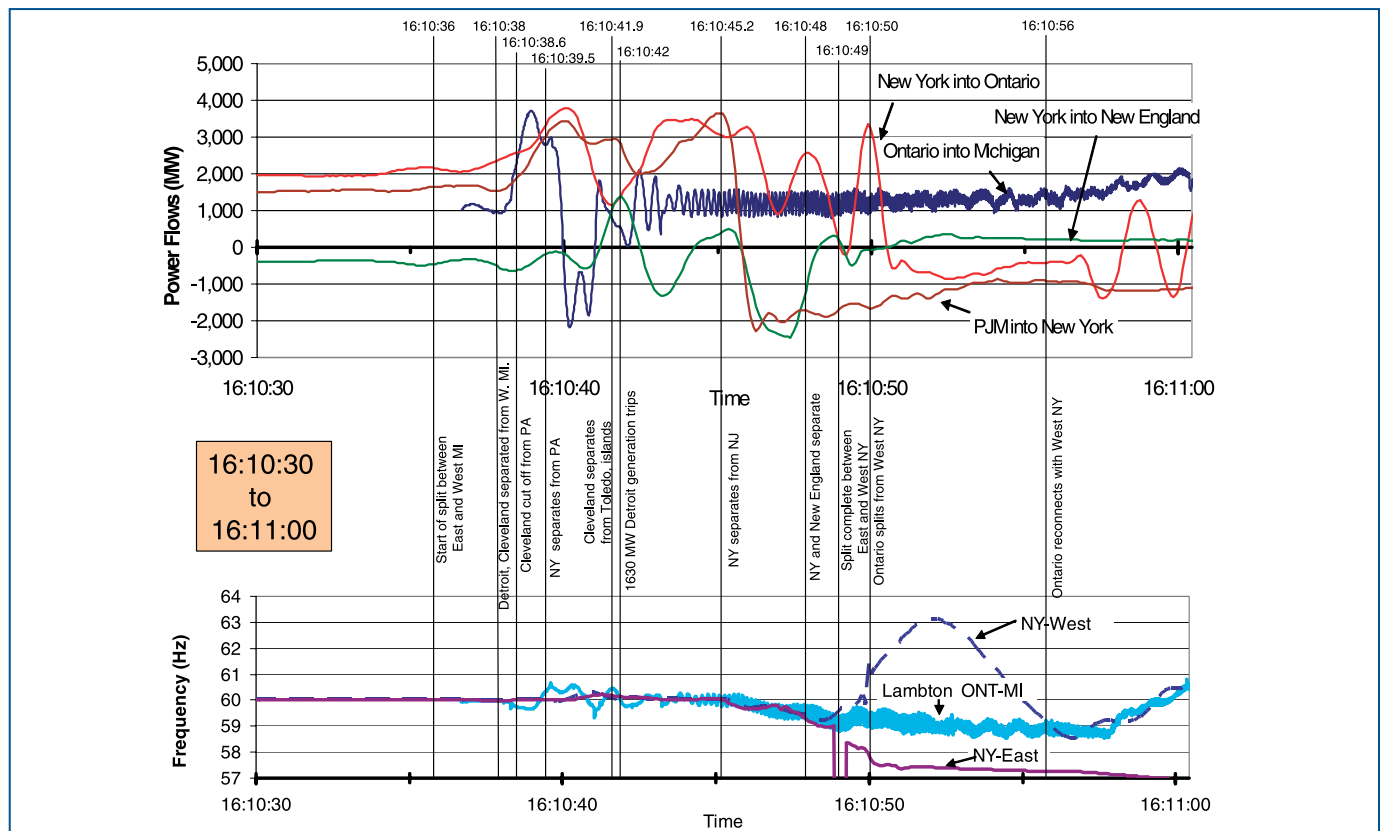
**Figure 6.17. Measured Power Flows and Frequency Across Regional Interfaces, 16:10:30 to 16:11:00 EDT, with Key Events in the Cascade**

Because the demand for power in Michigan, Ohio, and Ontario was drawing on lines through New York and Pennsylvania, heavy power flows were moving northward from New Jersey over the New York tie lines to meet those power demands, exacerbating the power swing. Figure 6.17 shows actual net line flows summed across the interfaces between the main regions affected by these swings—Ontario into Michigan, New York into Ontario, New York into New England, and PJM into New York. This shows clearly that the power swings did not move in unison across every interface at every moment, but varied in magnitude and direction. This occurred for two reasons. First, the availability of lines to complete the path across

each interface varied over time, as did the amount of load that drew upon each interface, so net flows across each interface were not facing consistent demand with consistent capability as the cascade progressed. Second, the speed and magnitude of the swing was moderated by the inertia, reactive power capabilities, loading conditions and locations of the generators across the entire region.

After Cleveland was cut off from Pennsylvania and eastern power sources, Figure 6.17 shows the start of the dynamic power swing at 16:10:38.6. Because the loads of Cleveland, Toledo and Detroit (less the load already blacked out) were now hanging off Michigan and Ontario, this forced a gigantic shift in power flows to meet that demand. As noted above, flows from Ontario into Michigan increased from 1,000 MW to 3,700 MW shortly after the start of the swing, while flows from PJM into New York were close behind. But within two seconds from the start of the swing, at 16:10:40 EDT flows reversed and coursed back from Michigan into Ontario at the same time that frequency at the interface dropped, indicating that significant generation had been lost. Flows that had been westbound across the Ontario-Michigan interface by over 3,700 MW at 16:10:38.8 dropped down to 2,100 MW eastbound by 16:10:40, and then returned westbound starting at 16:10:40.5.

Re-examination of Figure 6.17 shows the power swing from the northeast through Ontario into Michigan and northern Ohio that began at 16:10:37, and how it reverses and swings back around Lake Erie at 16:10:39 EDT. That return was caused by the combination of natural oscillations, accelerated by major load losses, as the northern Ohio system disconnected from Michigan. It caused a power flow change of 5,800 MW, from 3,700 MW westbound to 2,100 eastbound across the Ontario to Michigan border between 16:10:39.5 and 16:10:40 EDT. Since the system was now fully dynamic, this large oscillation eastbound would lead naturally to a rebound, which began at 16:10:40 EDT with an inflection point reflecting generation shifts between Michigan and Ontario and additional line losses in Ohio.

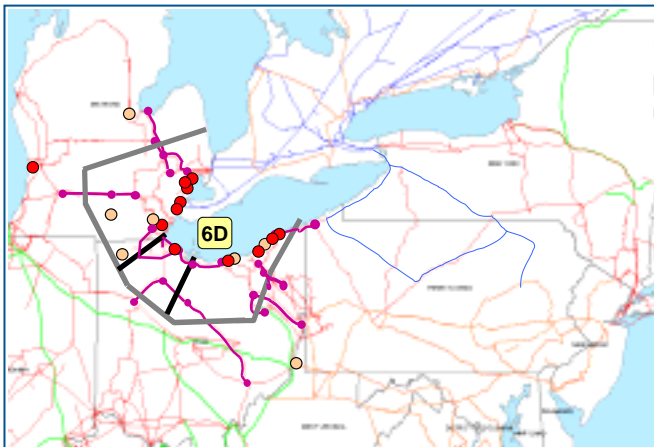
**Figure 6.18. Cleveland and Toledo Islanded, 16:10:39 to 16:10:46 EDT**

Back in northern Ohio, the trips of the Bay Shore-Monroe, Majestic-Lemoyne, Allen Junction-Majestic-Monroe 345-kV lines, and the Ashtabula 345/138-kV transformer cut off Toledo and Cleveland from the north, turning that area into an electrical island (Figure 6.18). Frequency in this large island began to fall rapidly. This caused a series of power plants in the area to trip

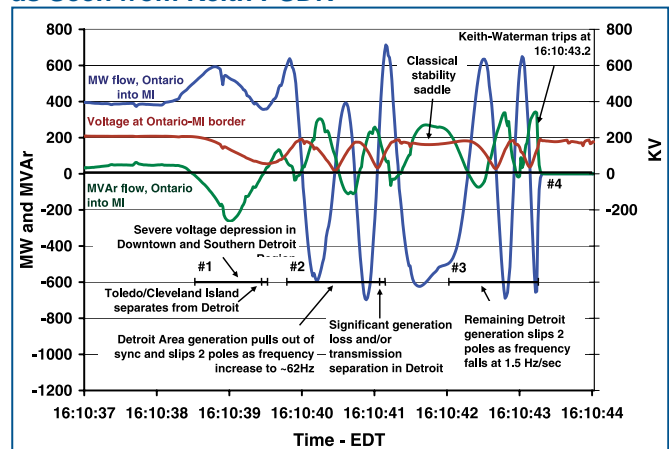
**Figure 6.19. Generators Under Stress in Detroit, as Seen from Keith PSDR**

The tremendous power flow into Michigan, beginning at 16:10:38, occurred when Toledo and Cleveland were still connected to the grid only through Detroit. After the Bay Shore-Monroe line tripped at 16:10:39, Toledo-Cleveland were separated into their own island, dropping a large amount of load off the Detroit system. This left Detroit suddenly with excess generation, much of which was greatly accelerated in angle as the depressed voltage in Detroit (caused by the high demand in Cleveland) caused the Detroit units to pull nearly out of step. With the Detroit generators

running at maximum mechanical output, they began to pull out of synchronous operation with the rest of the grid. When voltage in Detroit returned to near-normal, the generators could not fully pull back its rate of revolutions, and ended up producing excessive temporary output levels, still out of step with the system. This is evident in Figure 6.19, which shows at least two sets of generator “pole slips” by plants in the Detroit area between 16:10:40 EDT and 16:10:42 EDT. Several large units around Detroit—Belle River, St. Clair, Greenwood, Monroe, and Fermi—all tripped in response. After formation of the Cleveland-Toledo island at 16:10:40 EDT, Detroit frequency spiked to almost 61.7 Hz before dropping, momentarily equalized between the Detroit and Ontario systems, but Detroit frequency began to decay at 2 Hz/sec and the generators then experienced under-speed conditions.

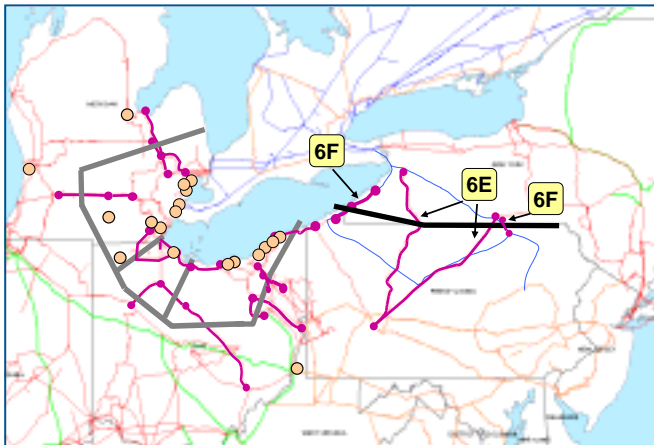
**Figure 6.20. Western Pennsylvania Separates from New York, 16:10:39 EDT to 16:10:44 EDT**

Responding to the swing of power out of Michigan toward Ontario and into New York and PJM, zone 1 relays on the 345-kV lines separated Pennsylvania from New York (Figure 6.20). Homer City-Watercure (177 miles or 285 km) and Homer City-Stolle Road (207 miles or 333 km) are very long lines and so have high impedance. Zone 1 relays do not have timers, and operate instantly when a power swing enters the relay target circle. For normal length lines, zone 1 relays have small target circles because the relay is measuring a less than the full length of the line—but for a long line the large line impedance enlarges the relay’s target circle and makes it more likely to be hit by the power swing. The Homer City-Watercure and Homer City-Stolle Road lines do not have zone 3 relays.

Given the length and impedance of these lines, it was highly likely that they would trip and separate early in the face of such large power swings. Most of the other interfaces between regions are on short ties—for instance, the ties between New York and Ontario and Ontario to Michigan are only about 2 miles (3.2 km) long, so they are electrically very short and thus have much lower impedance and trip less easily than these long lines. A zone 1 relay target for a short line covers a
