**U.S.-Canada Power System Outage Task Force**

**Final Report on the  
August 14, 2003 Blackout  
in the  
United States and Canada:**

**Causes and  
Recommendations**

**April 2004**

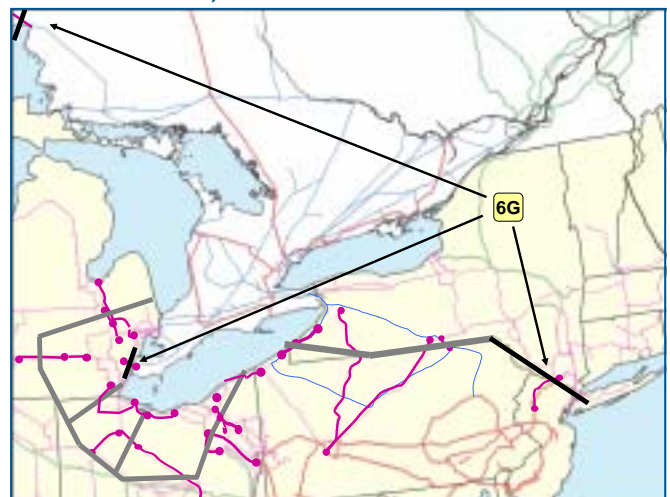
**Figure 6.21. Northeast Separates from Eastern Interconnection, 16:10:45 EDT**

At 16:10:43 EDT, eastern Michigan was still connected to Ontario, but the Keith-Waterman 230-kV line that forms part of that interface disconnected due to apparent impedance (Figure 6.21). This put more power onto the remaining interface between Ontario and Michigan, but

triggered sustained oscillations in both power flow and frequency along the remaining 230-kV line.

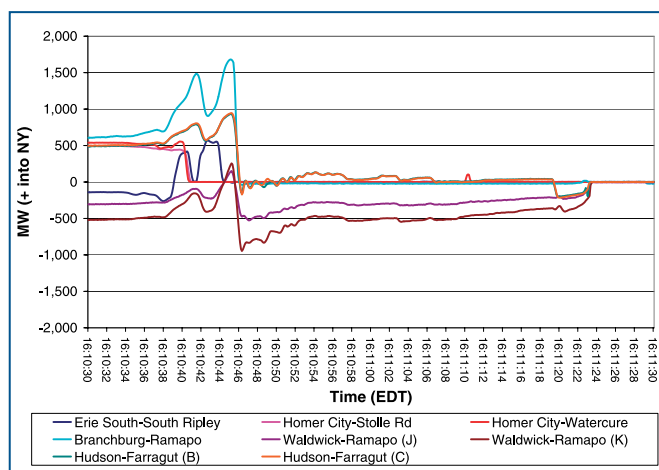
**Figure 6.22. PJM to New York Interties Disconnect**

The 69-mile (111 km) long Branchburg-Ramapo 500-kV line and Ramapo transformer between New Jersey and New York was the last major transmission path remaining between the Eastern Interconnection and the area ultimately affected by the blackout. Figure 6.22 shows how that line disconnected at 16:10:45 EDT, along with other underlying 230 and 138-kV lines in northeast New Jersey. Branchburg-Ramapo was carrying over 3,000 MVA and 4,500 amps with voltage at 79% before it tripped, either on a high-speed swing into zone 1 or on a direct transfer trip. The investigation team is still examining why the higher impedance 230-kV overhead lines tripped while the underground Hudson-Farragut 230-kV cables did not; the available data suggest that the notably lower impedance of underground cables made these less vulnerable to the electrical strain placed on the system.

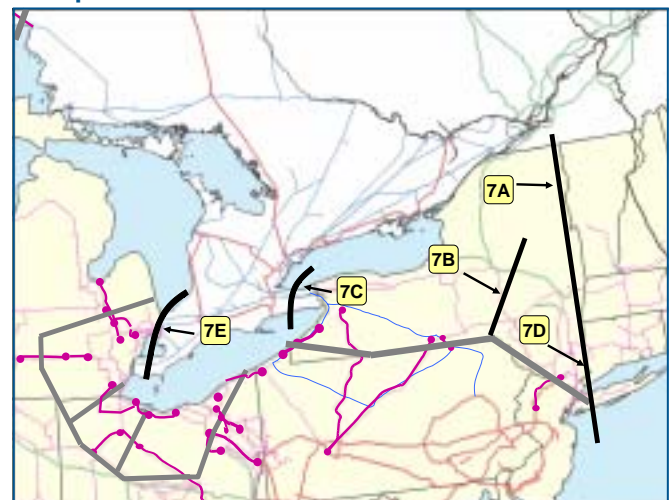
**Figure 6.23. New York and New England Separate, Multiple Islands Form**

During the next 3 seconds, the islanded northern section of the Eastern Interconnection broke apart internally. Figure 6.23 illustrates the events of this phase.

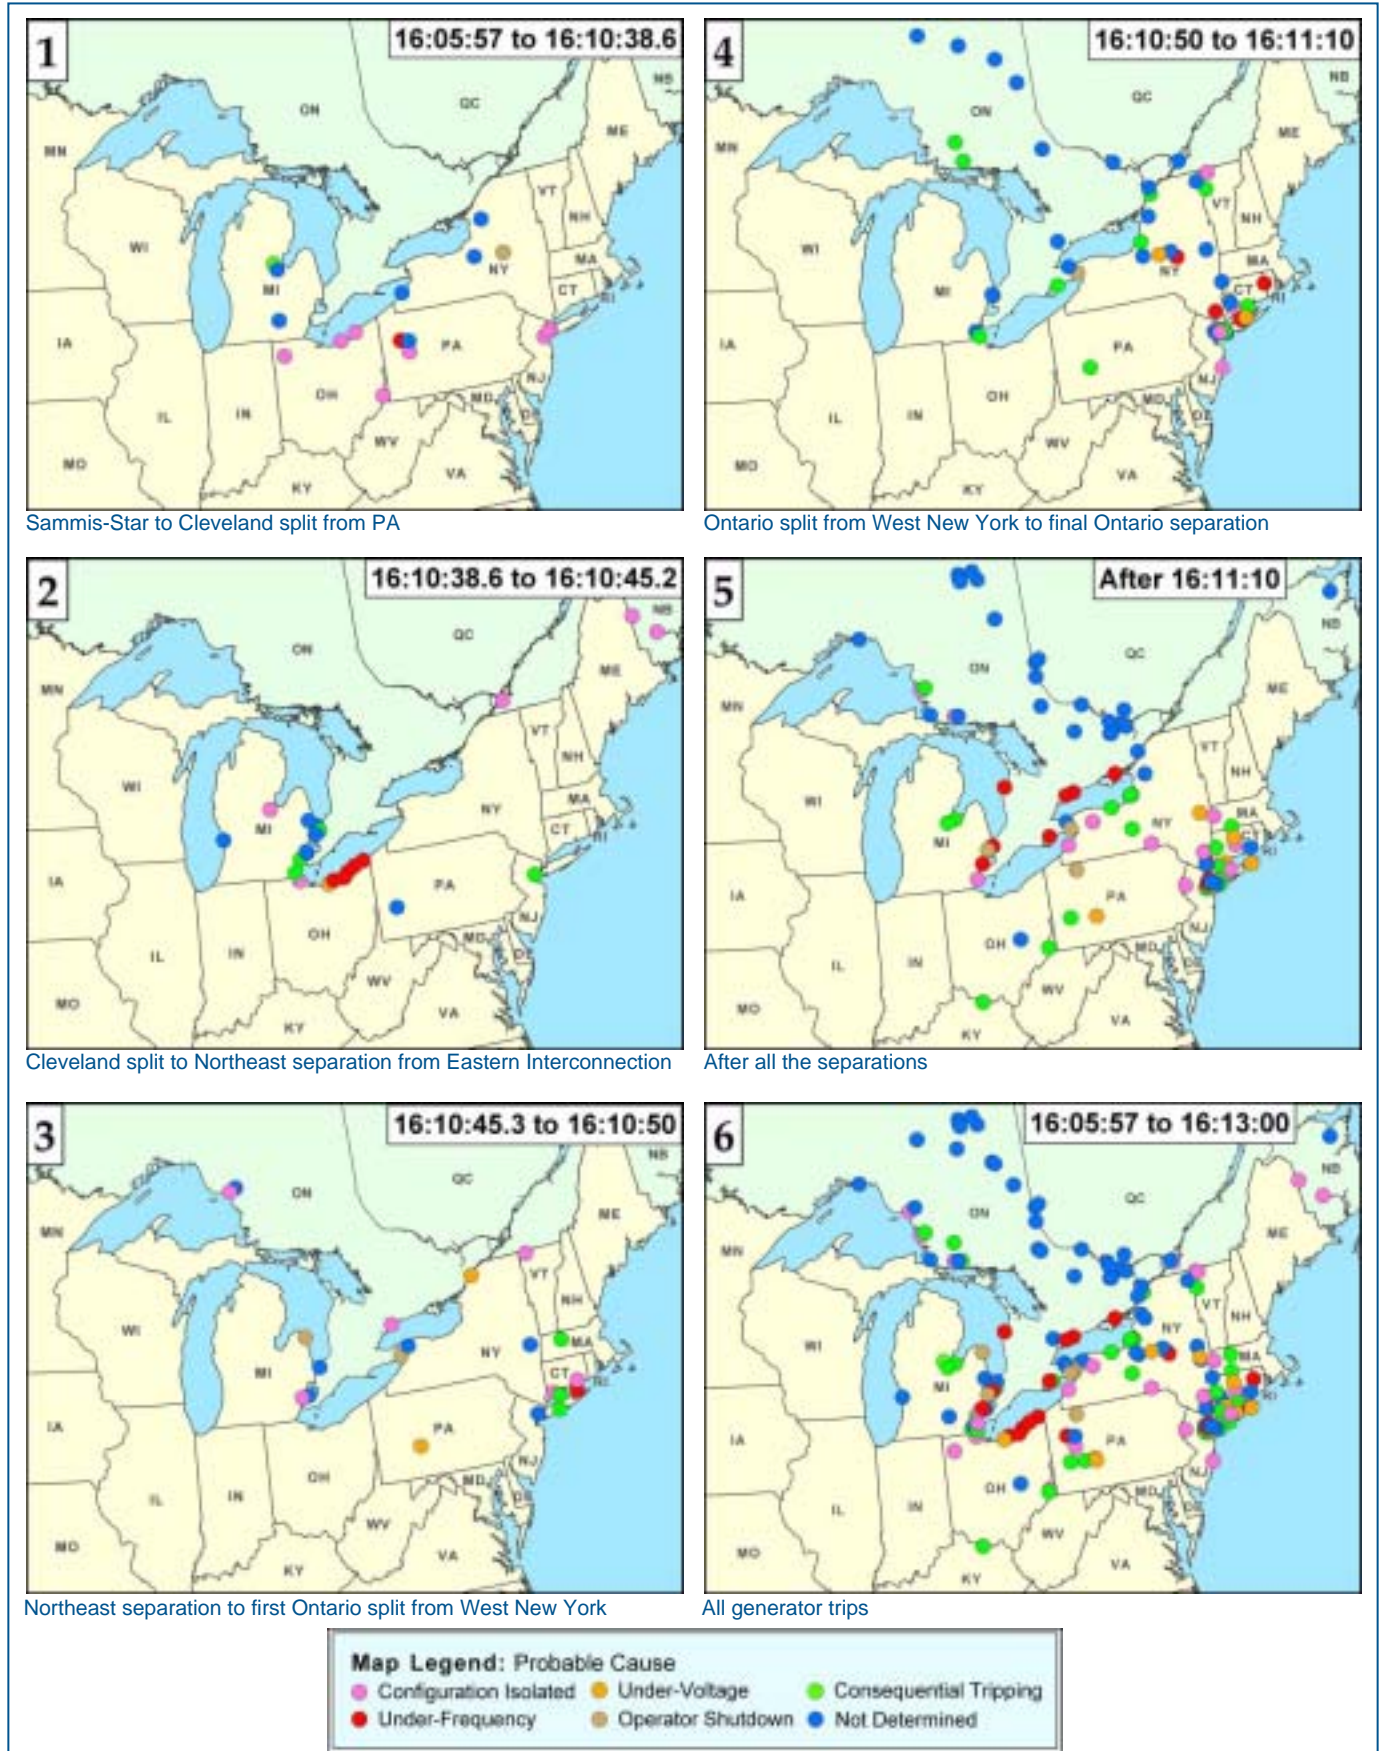
Figure 6.24. Generator Trips by Time and Cause

Within the overall cascade sequence, 29 (6%) generators tripped between the start of the cascade at 16:05:57 (the Sammis-Star trip) and the split between Ohio and Pennsylvania at 16:10:38.6 EDT (Erie West-Ashtabula-Perry), which triggered the first big power swing. These trips were caused by the generators' protective relays responding to overloaded transmission lines, so many of these trips were reported as under-voltage or over-current. The next interval in the cascade was as the portions of the grid lost synchronism, from 16:10:38.6 until 16:10:45.2 EDT, when Michigan-New York-Ontario-New England separated from the rest of the Eastern Interconnection. Fifty more generators (10%) tripped as the islands formed, particularly due to changes in configuration, loss of synchronism, excitation system failures, with some under-frequency and under-voltage. In the third phase of generator losses, 431 generators (84%) tripped after the islands formed,

many at the same time that under-frequency load-shedding was occurring. This is illustrated in Figure 6.24. It is worth noting, however, that many generators did not trip instantly after the trigger condition that led to the trip—rather, many relay protective devices operate on time delays of milliseconds to seconds in duration, so that a generator that reported tripping at 16:10:43 on under-voltage or “generator protection” might have experienced the trigger for that condition several seconds earlier.

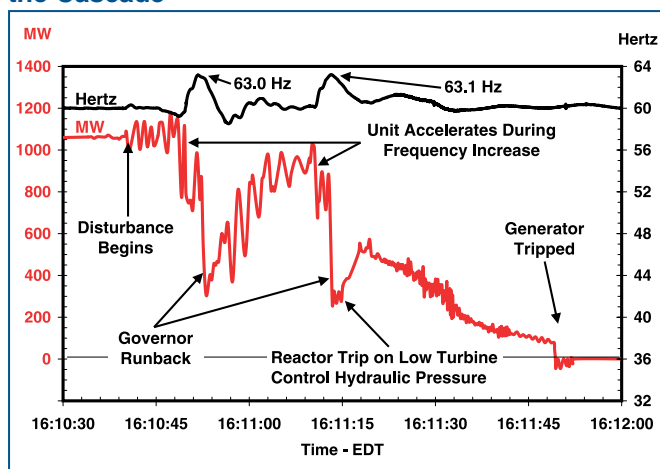
**Figure 6.25. Events at One Large Generator During the Cascade**

it back again as some frequencies changed several times by as much as 3 Hz (about 100 times normal deviations). Figure 6.25 is a plot of the MW output and frequency for one large unit that nearly survived the disruption but tripped when in-plant hydraulic control pressure limits were eventually violated. After the plant control system called for shutdown, the turbine control valves closed and the generator electrical output ramped down to a preset value before the field excitation tripped and the generator breakers opened to disconnect the unit from the system. This also illustrates the time lag between system events and the generator reaction—this generator was first disturbed by system conditions at 16:10:37, but did not trip until 16:11:47, over a minute later.

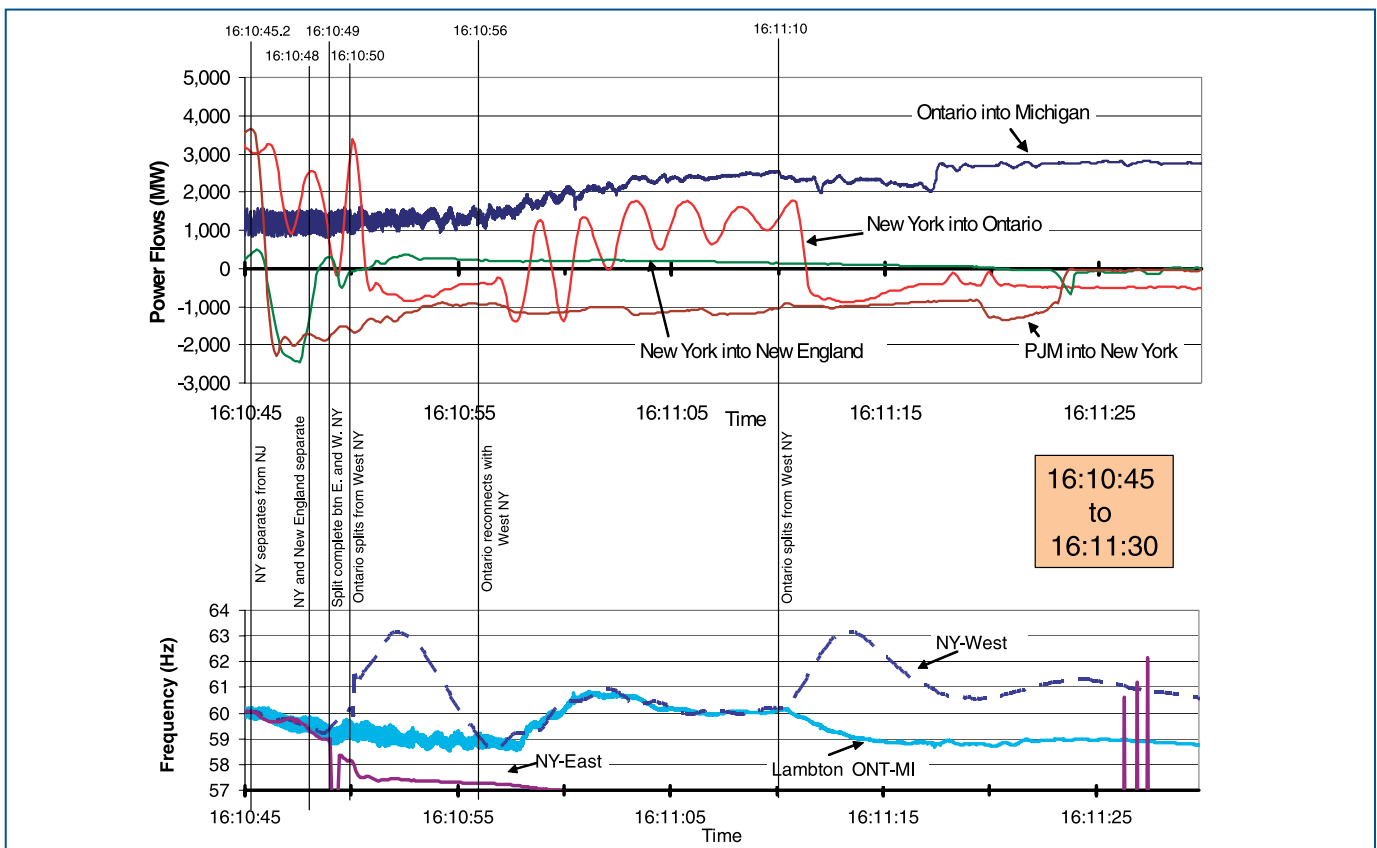
**Figure 6.26. Measured Power Flows and Frequency Across Regional Interfaces, 16:10:45 to 16:11:30 EDT, with Key Events in the Cascade**

Figure 6.26 gives an overview of the power flows and frequencies in the period 16:10:45 EDT through 16:11:00 EDT, capturing most of the key events in Phase 7.

Examination of the loads and generation in the Eastern New York island indicates before 16:10:00 EDT, the area had been importing electricity and had less generation on-line than load. At 16:10:50 EDT, seconds after the separation along the Total East interface, the eastern New York area had experienced significant load reductions due to under-frequency load-shedding—Consolidated Edison, which serves New York City and surrounding areas, dropped over 40% of its load on automatic UFLS. But at this time, the system was still experiencing dynamic conditions—as illustrated in Figure 6.26, frequency was falling, flows and voltages were oscillating, and power plants were tripping off-line.

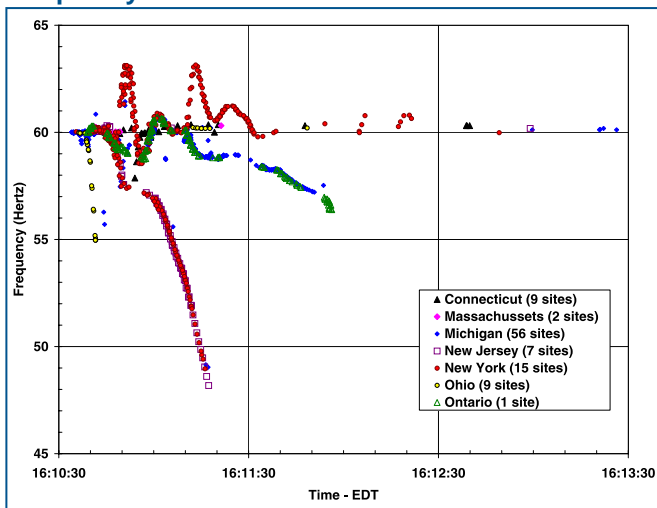
**Figure 6.28. Electric Islands Reflected in Frequency Plot**

Figure 6.28 shows frequency data collected by the distribution-level monitors of Softswitching Technologies, Inc. (a commercial power quality company serving industrial customers) for the area affected by the blackout. The data reveal at least five separate electrical islands in the Northeast as the cascade progressed. The two paths of red diamonds on the frequency scale reflect the Albany area island (upper path) versus the New York City island, which declined and blacked out much earlier.

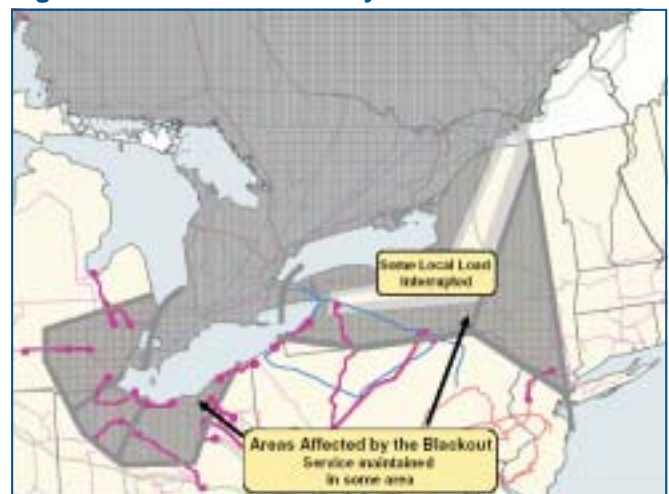
**Figure 6.29. Area Affected by the Blackout**

Most of the Northeast (the area shown in gray in Figure 6.29) was now blacked out. Some isolated areas of generation and load remained on-line for several minutes. Some of those areas in which a close generation-demand balance could be maintained remained operational.

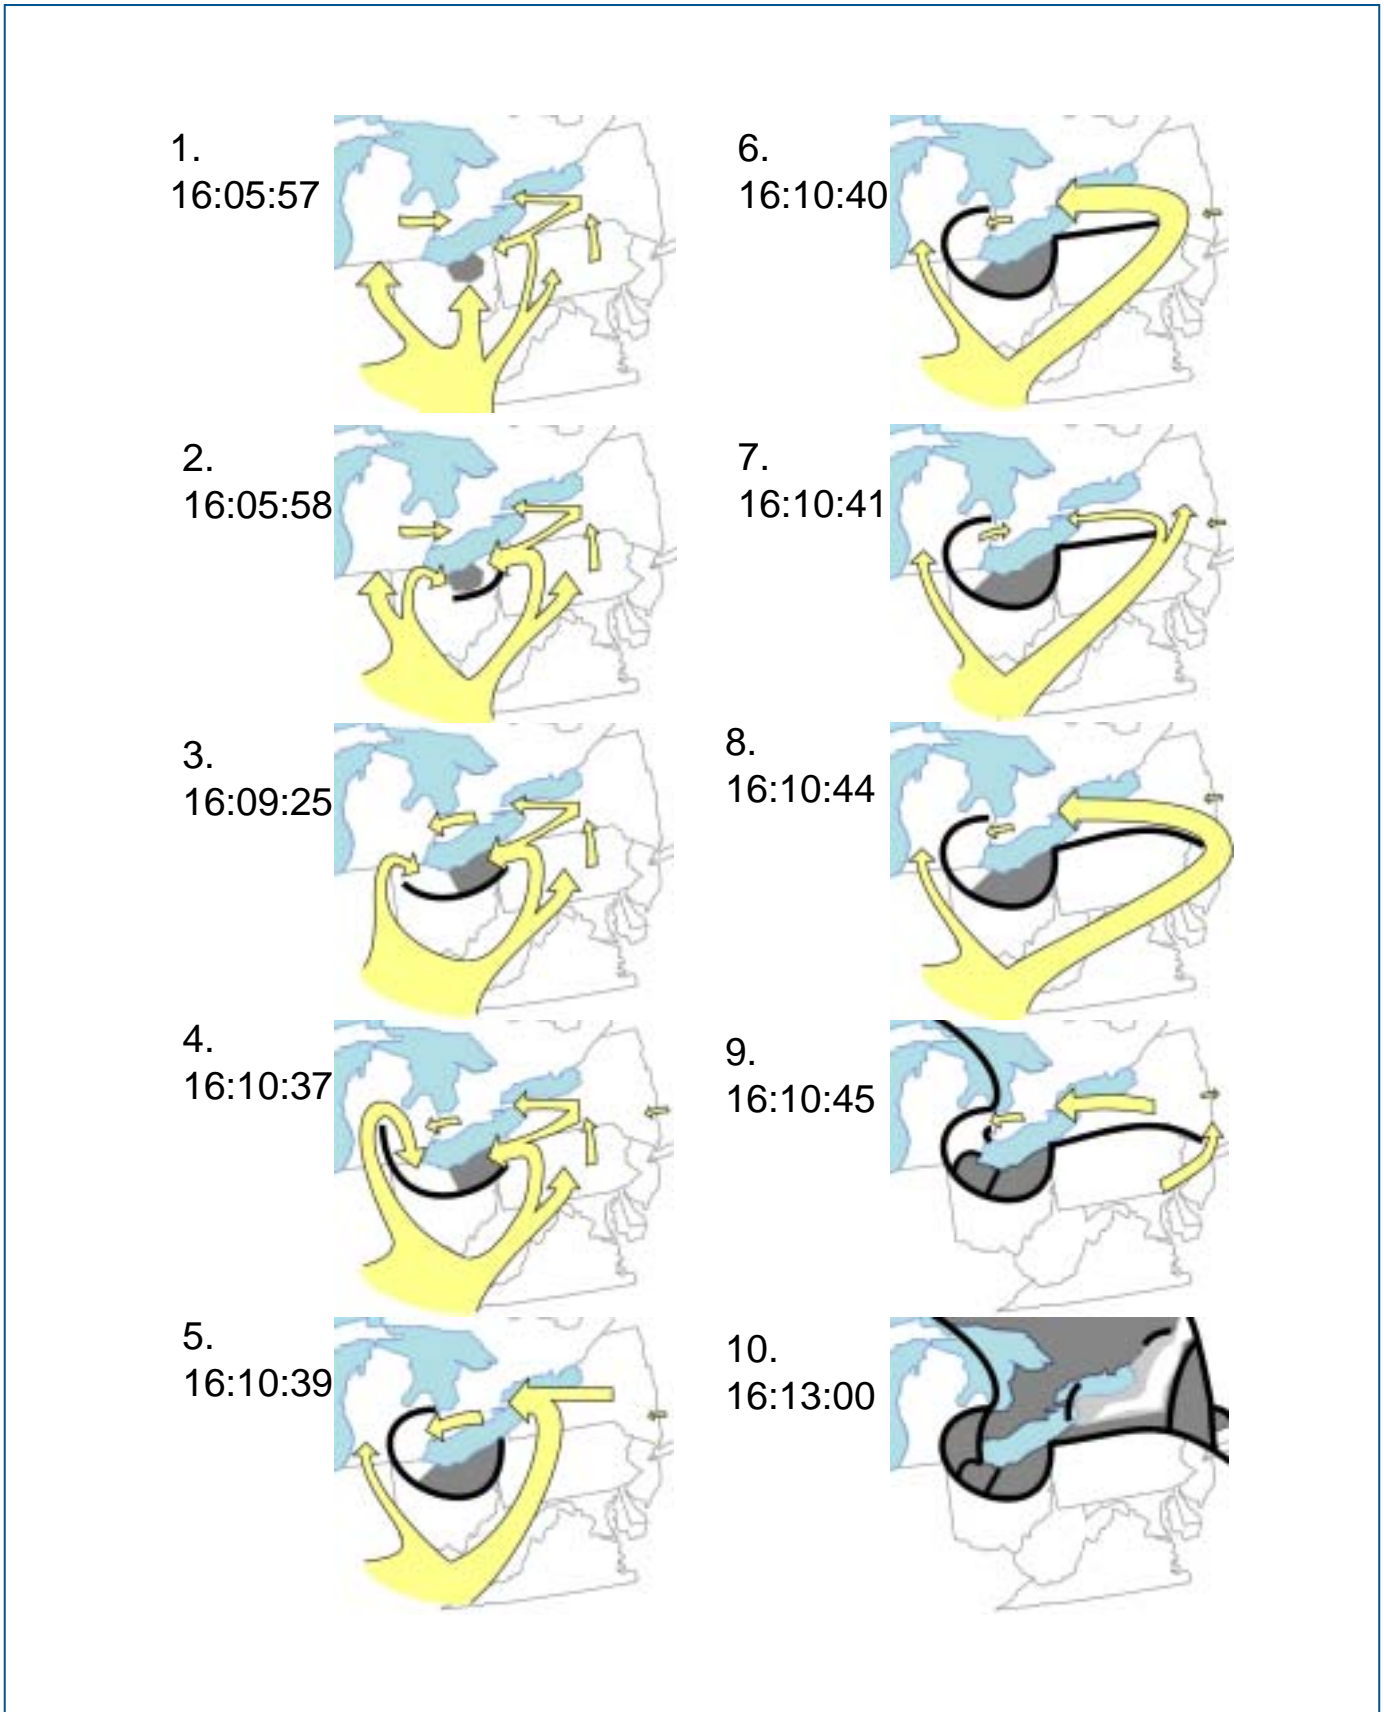
**Figure 6.30. Cascade Sequence**

The entire cascade sequence is depicted graphically in Figure 6.30.

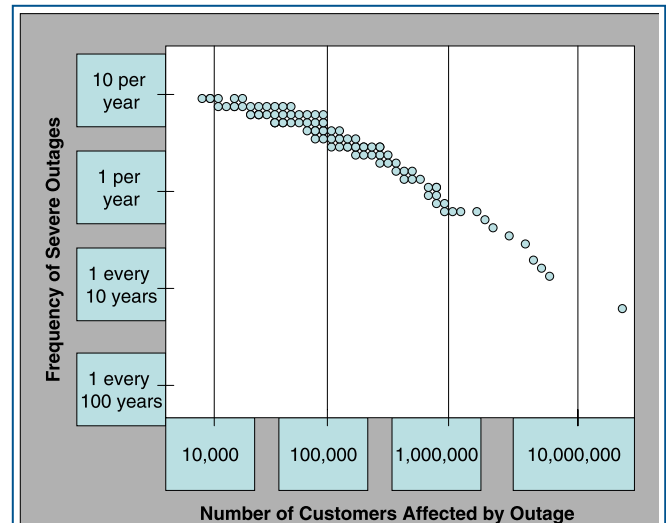
Figure 7.1. North American Power System Outages, 1984-1997

Short, localized outages occur on power systems fairly frequently. System-wide disturbances that affect many customers across a broad geographic area are rare, but they occur more frequently than a normal distribution of probabilities would predict. North American power system outages between 1984 and 1997 are shown in Figure 7.1 by the number of customers affected and the rate of occurrence. While some of these were widespread weather-related events, some were cascading events that, in retrospect, were preventable. Electric power systems are fairly robust and are capable of withstanding one or two contingency events, but they are fragile with respect to multiple contingency events unless the systems are readjusted between contingencies. With the shrinking margin in the current transmission system, it is likely to be more vulnerable to cascading outages than it was in the past, unless effective countermeasures are taken.
